E4 Environment Limited

Ledbury Road, Hereford

# **Arboricultural Assessment**

September 2015

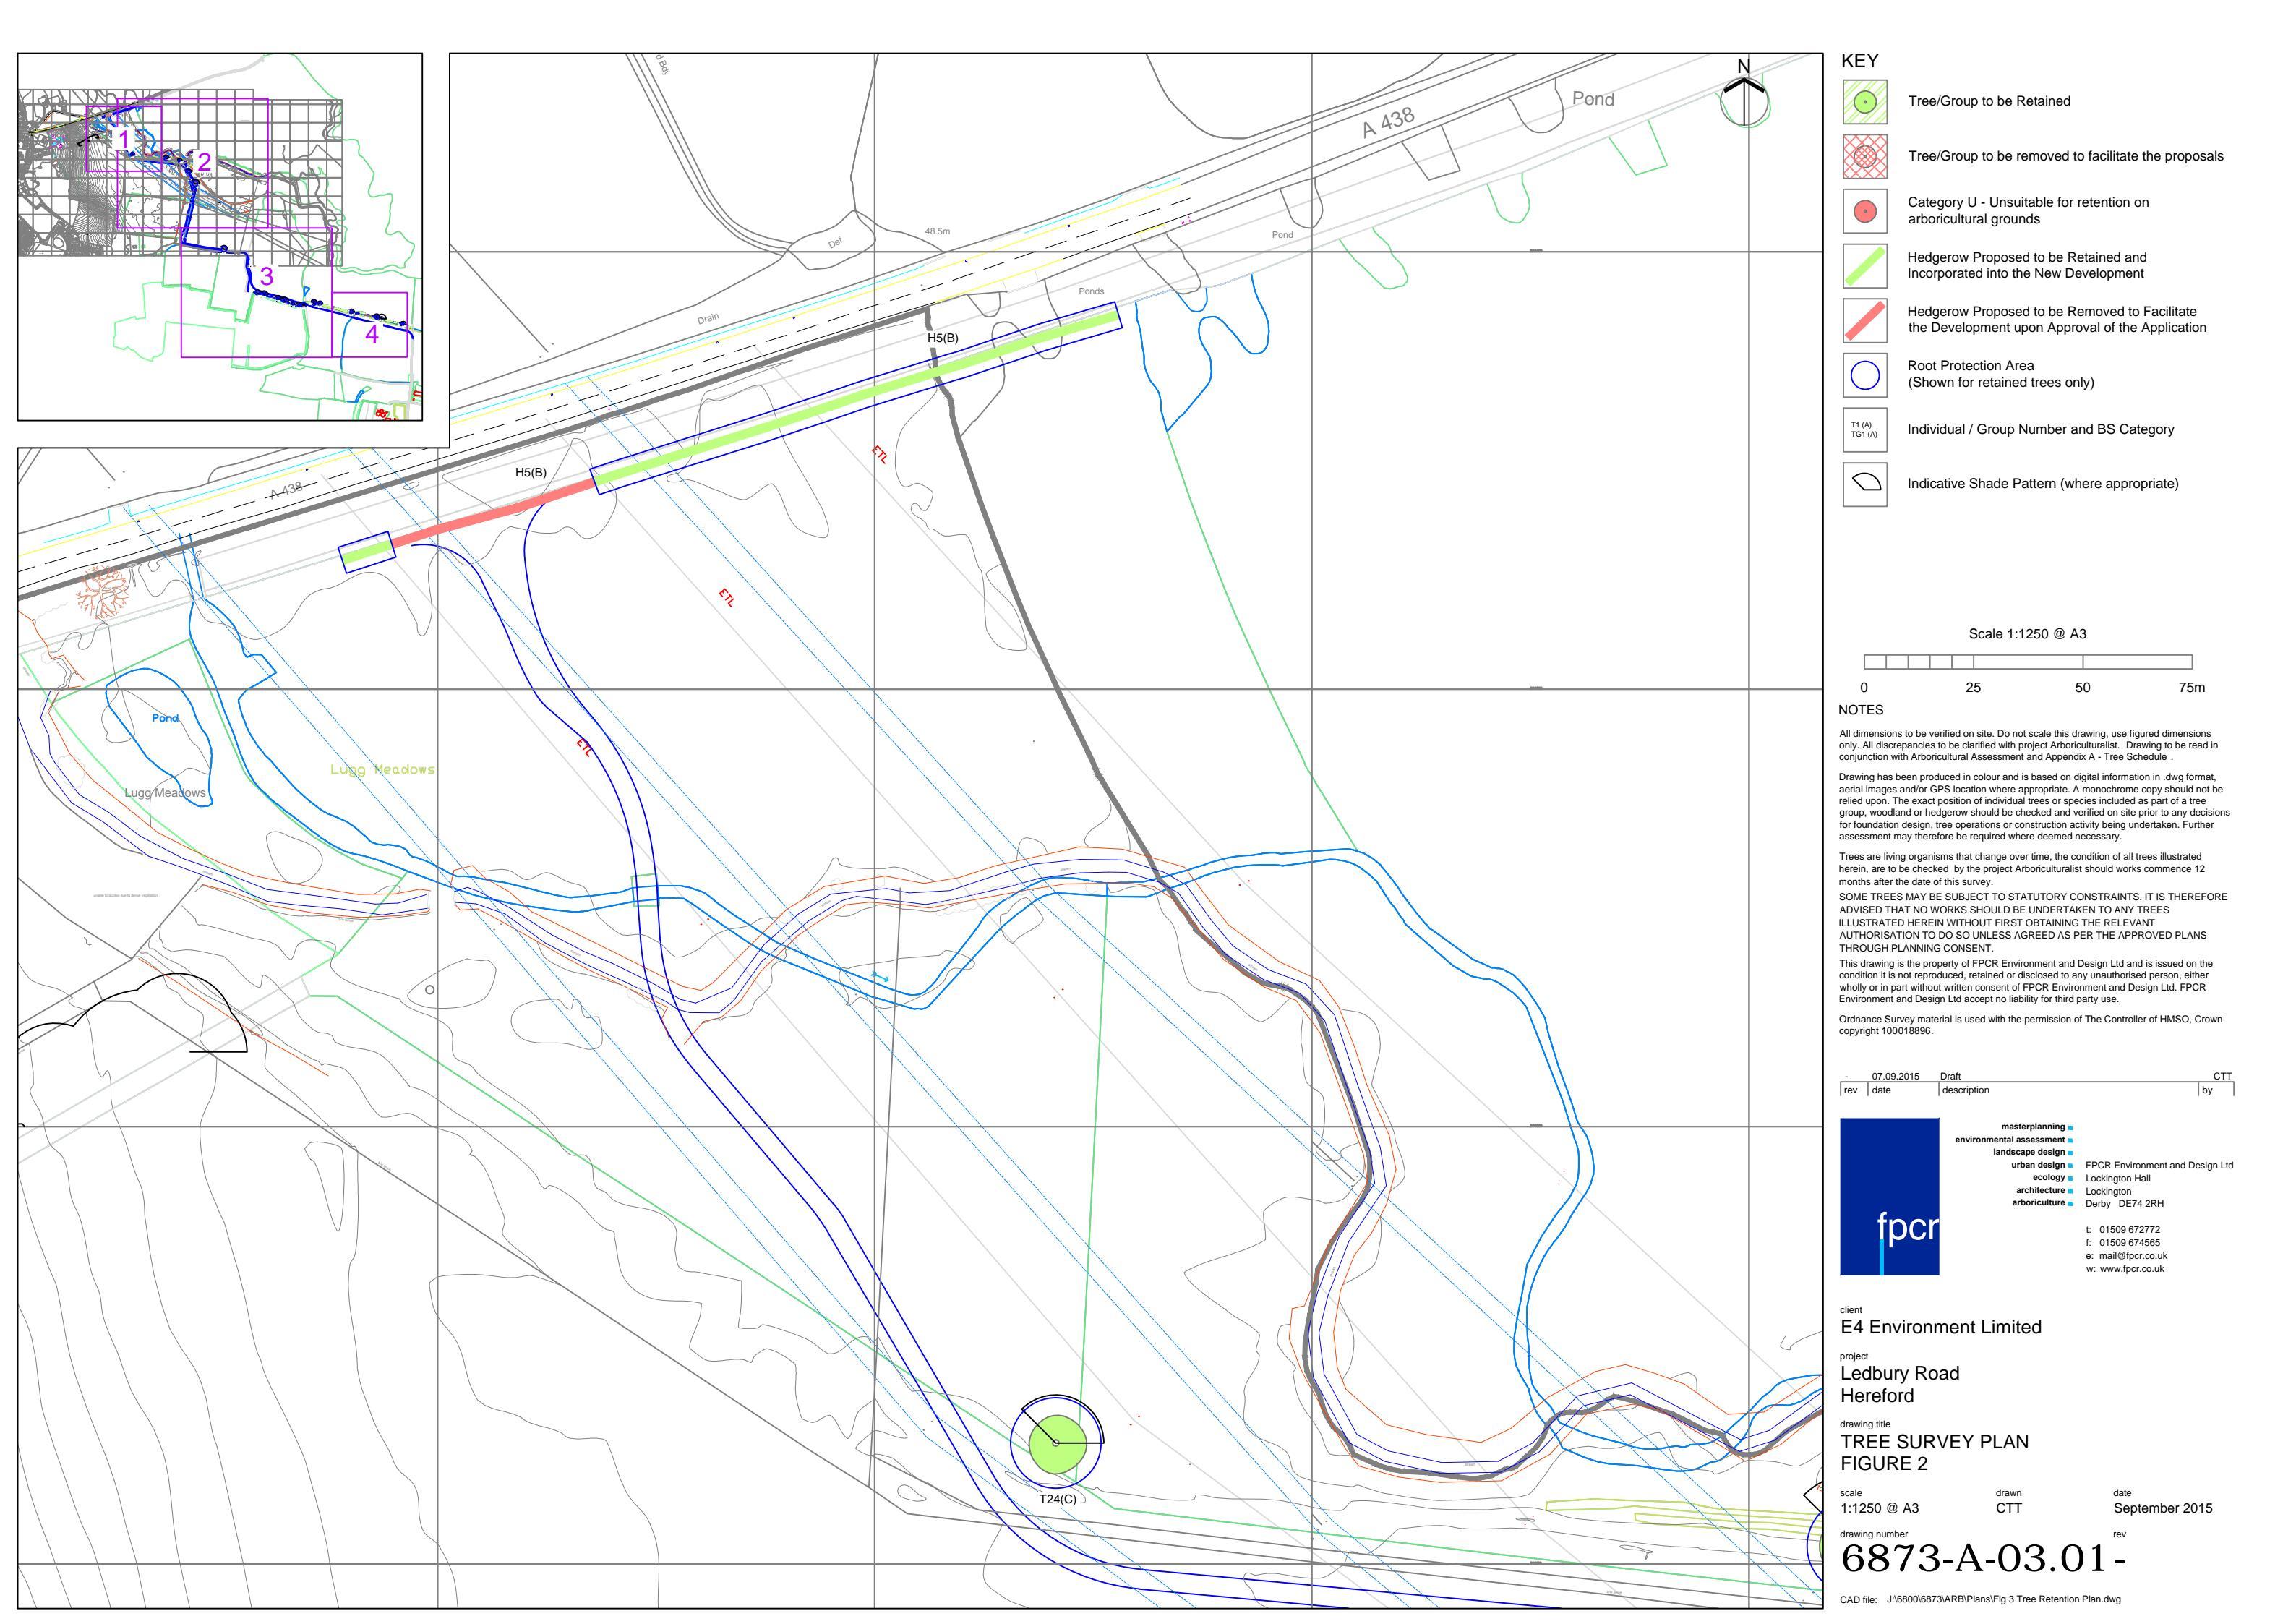
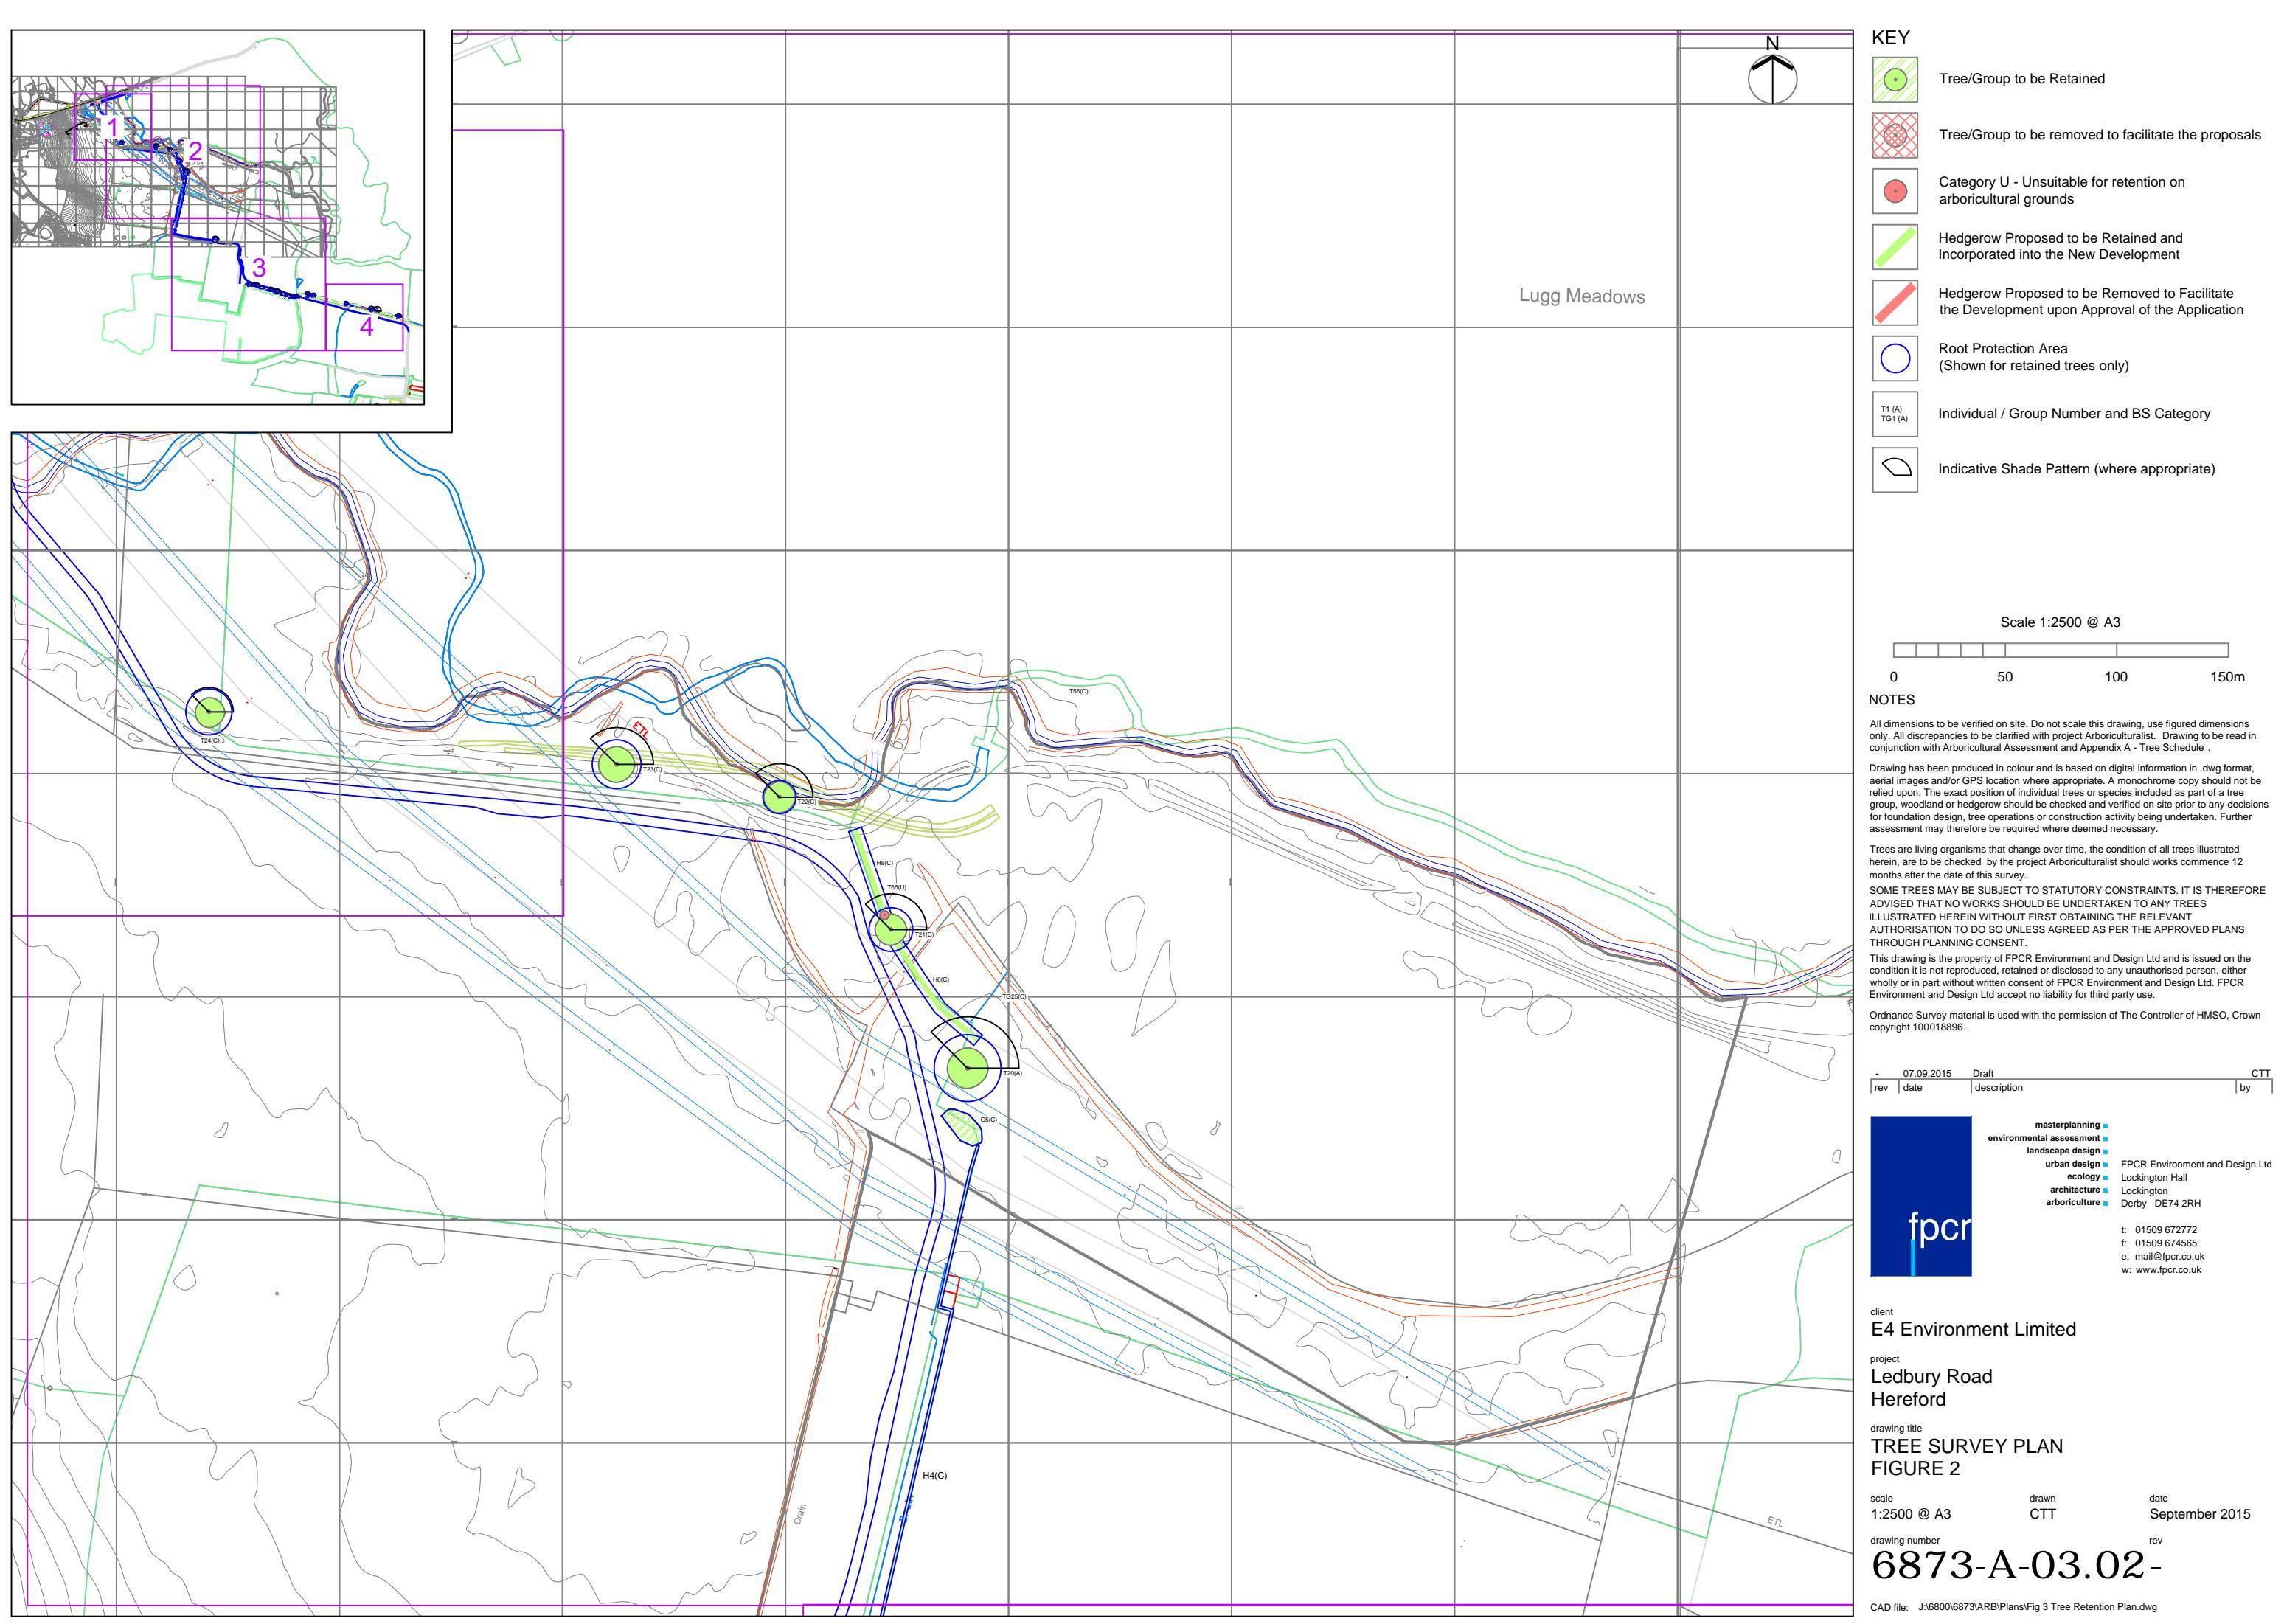
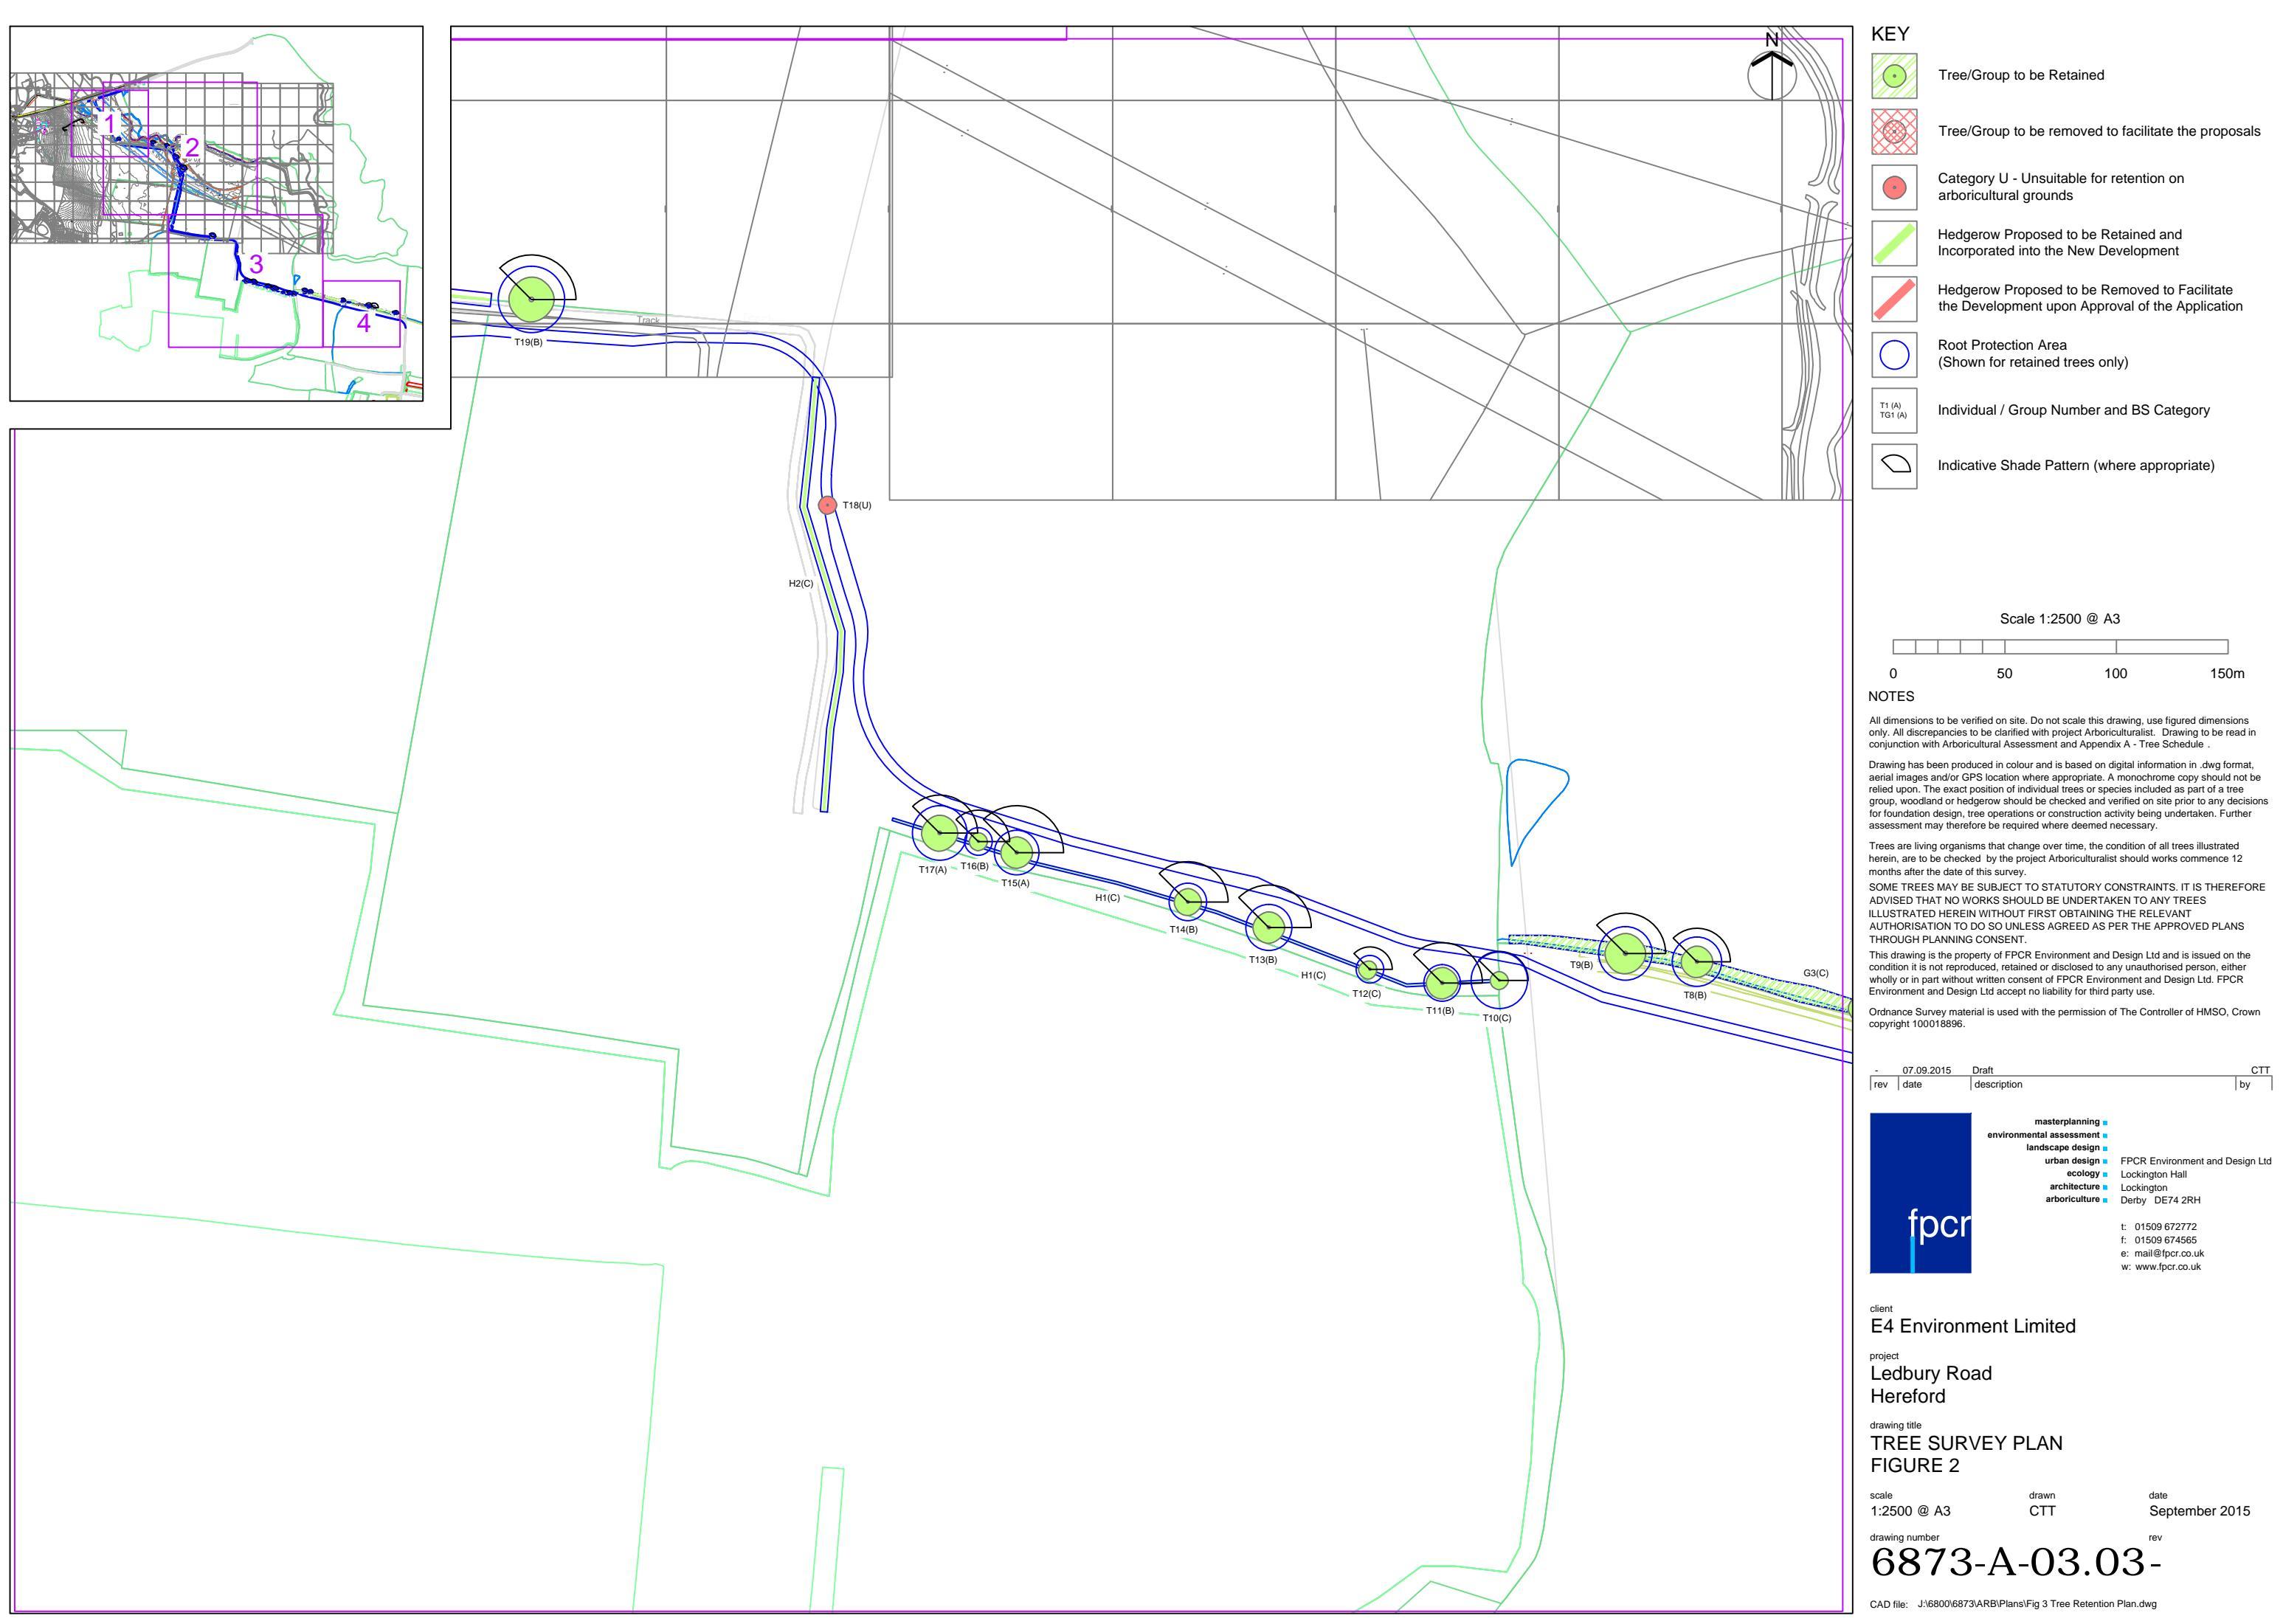
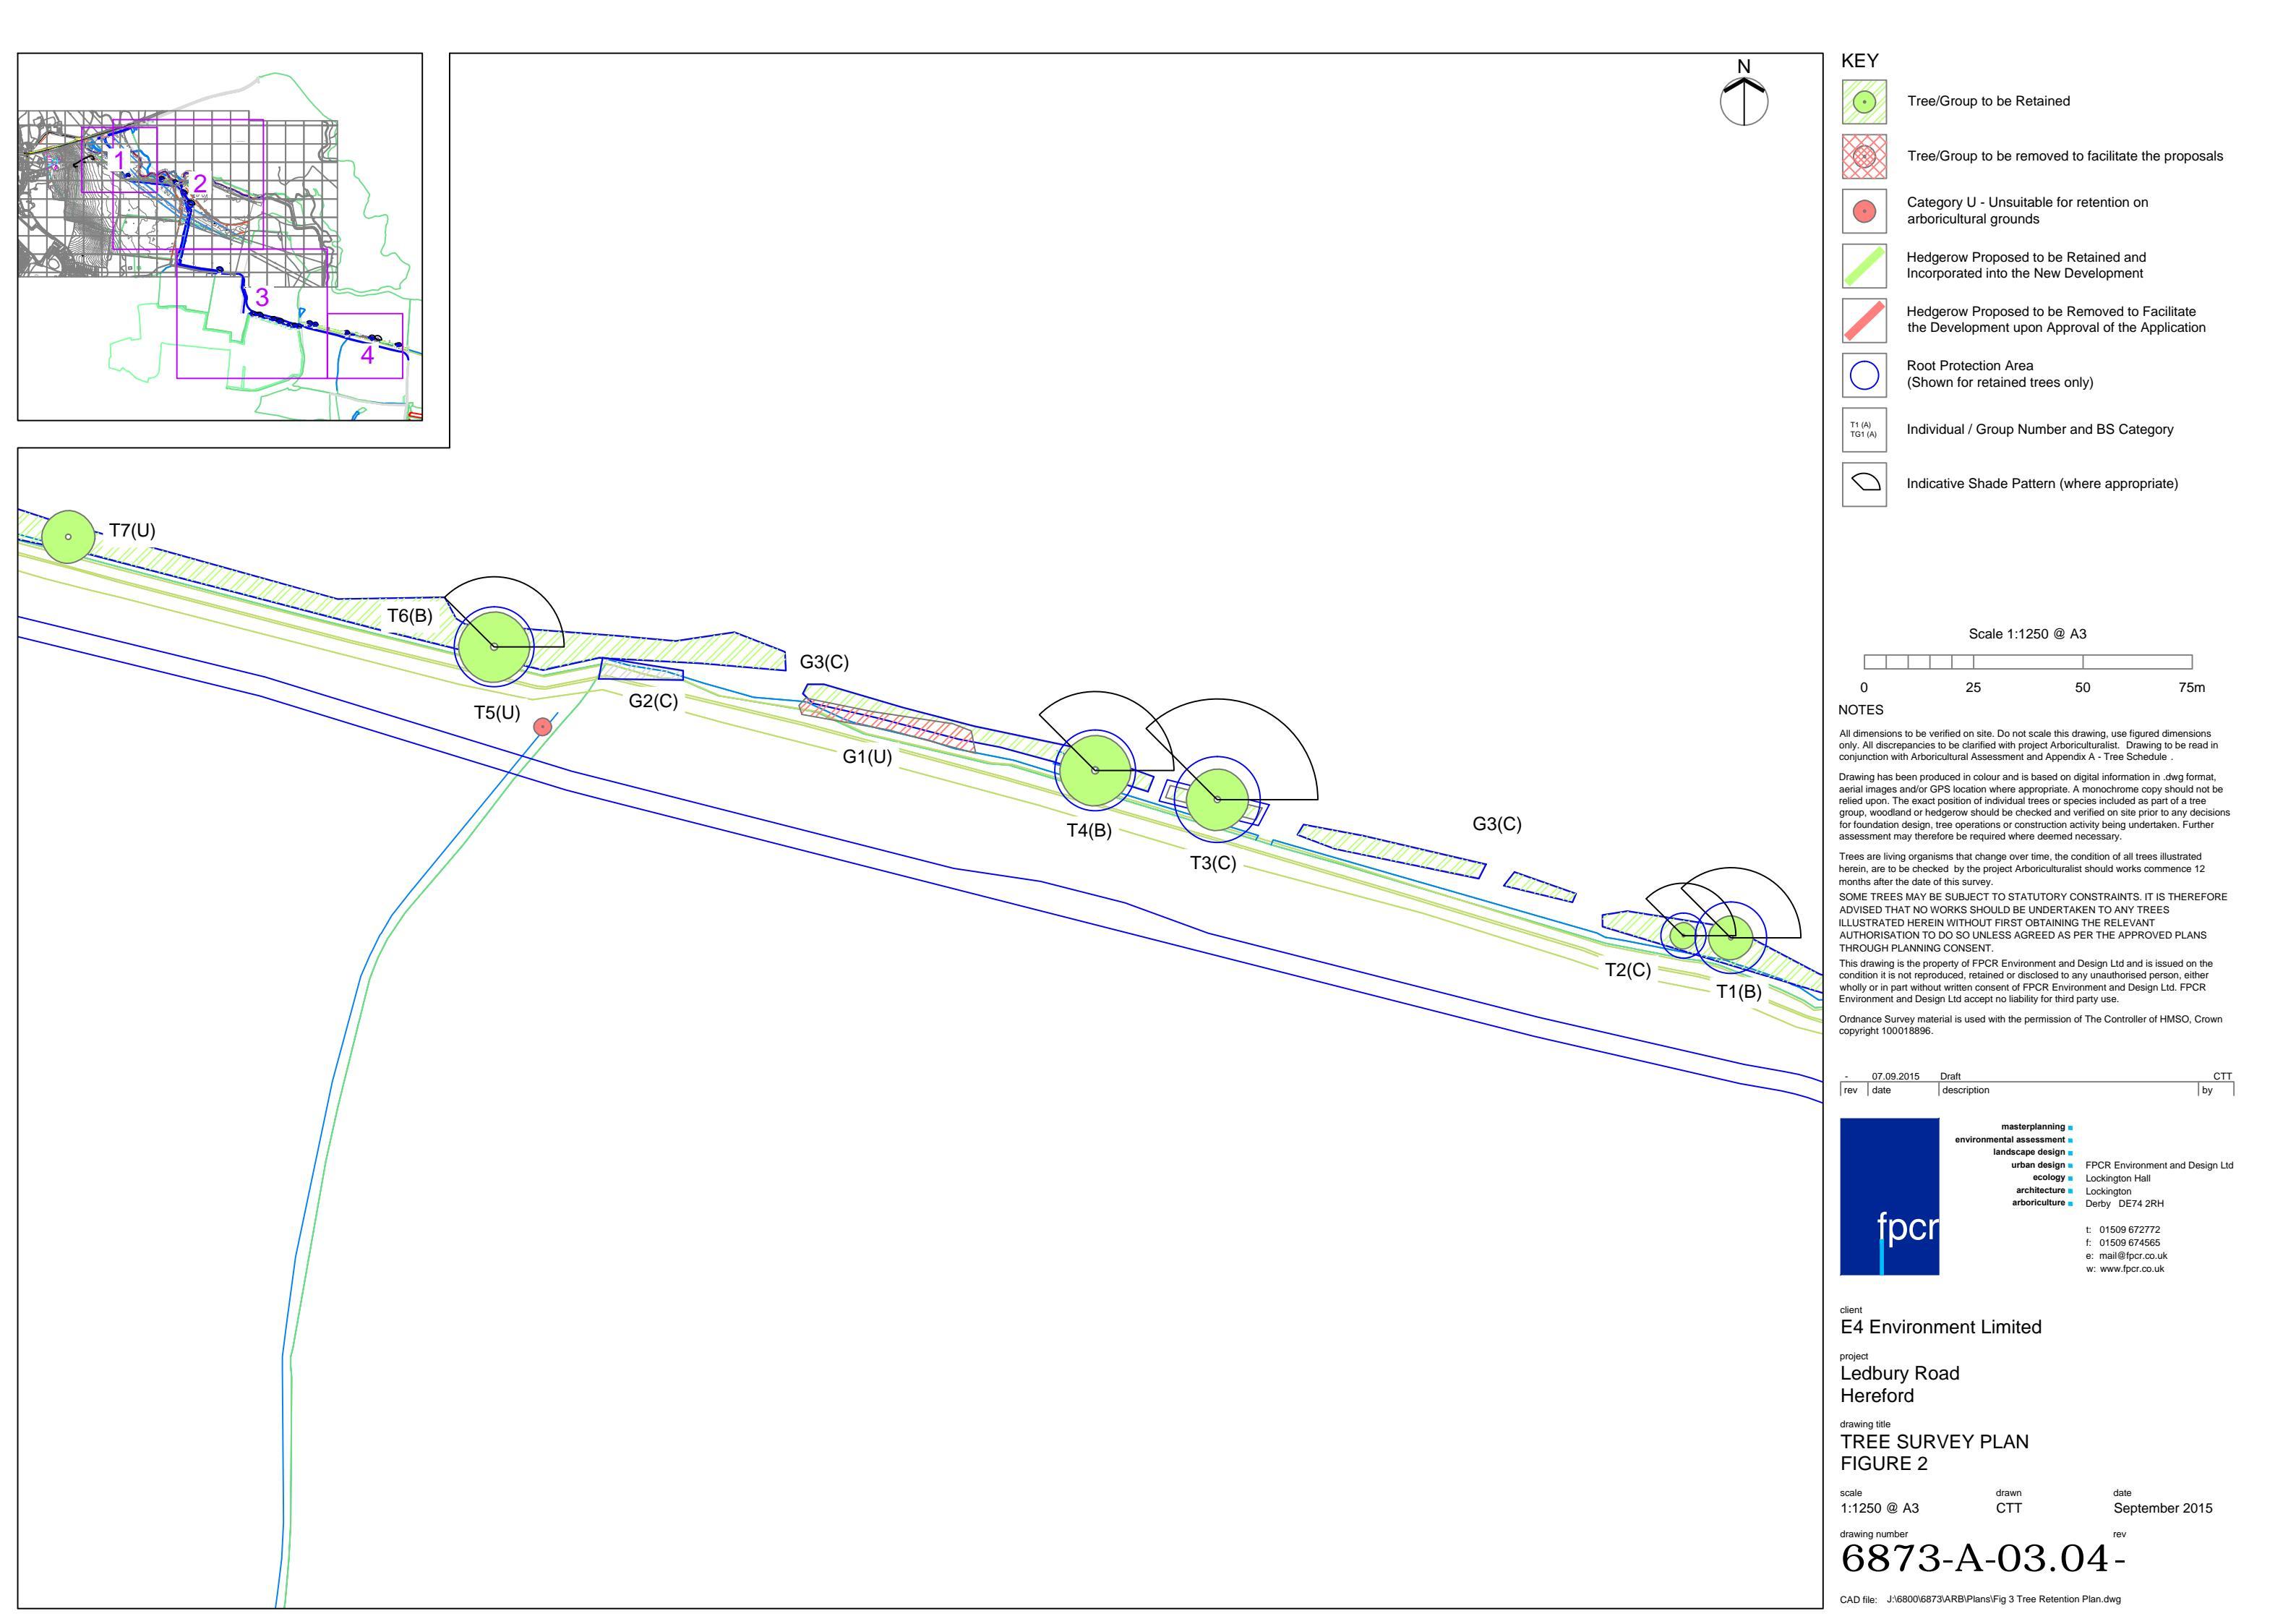
Figure 3: Tree Retention Plan (6873-A-03.01, 6873-A-03.02, 6873-A-03.03, 6873-A-03.04)

- 4.3 An overlay of the above layout has been incorporated in the Figure 3 Tree Retention Plan (drwg.no. 6873-A-03.01, 6873-A-03.02, 6873-A-03.03, 6873-A-03.04) to assist in identifying potential conflicts with the existing trees. In particular, an evaluation of the rooting influence from any trees in close proximity to the proposed track has been taken into account for any damage that may occur to the physical root systems.

- 4.8 The proposed access roads indicative alignment encroaches within the root protection area (RPA) of T10 and along the southern edge of T19's RPA. It is therefore recommended during the final design stages that the road layout is amended where possible to outside the RPA of these specimens. Should the position of the road be otherwise constrained and restricted in any modification to its proposed alignment in this instance it is should be highlighted that presently there is an existing single passage farm track constructed of compacted gravel/hardcore passing within the RPA's of both T10 and T19.

- 4.12 It is recommended that the use of "tree-friendly" sympathetic construction techniques are considered, utilising the principles of "no-dig" construction road surfaces within the RPA;s of the trees affected by the access road (T10 and T19). Specific details of these methods should be formalised within an appropriate Arboricultural Method Statement (AMS) which would support the Arboricultural Assessment. This is a viable option to minimise the impact to the rooting environments of these trees as the road shall be privately owned and maintained upon its completion. At current these types of construction techniques are currently unadoptable by Highways Agencies however this is not a material consideration in this instance.

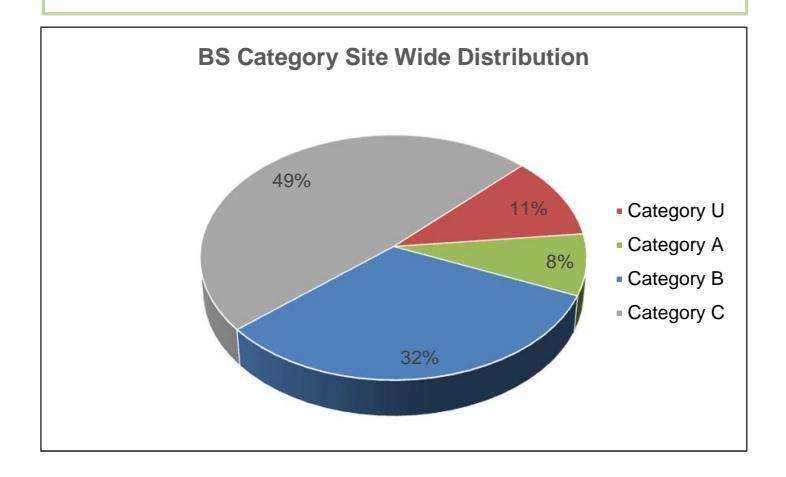
**BS Category Site Wide Distribution** shows the proportion of trees assessed in each category across the whole site which allows an interpretation of the site's overall quality.

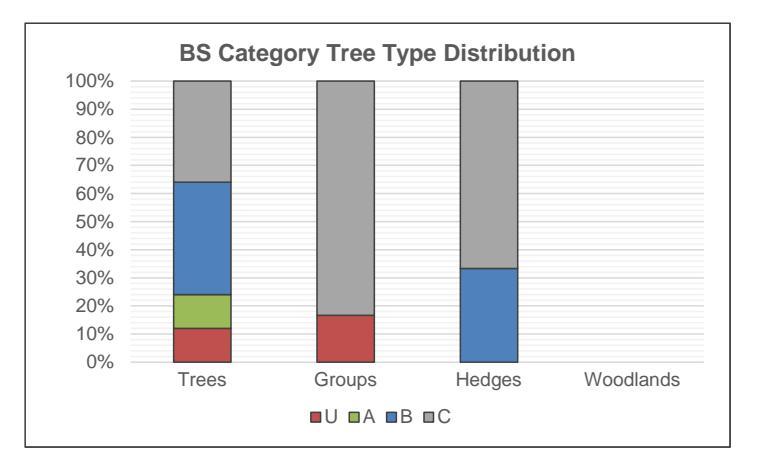
**BS Category Tree Type Distribution** displays the proportion of trees assessed in each type to enable a better understanding of the category distribution.

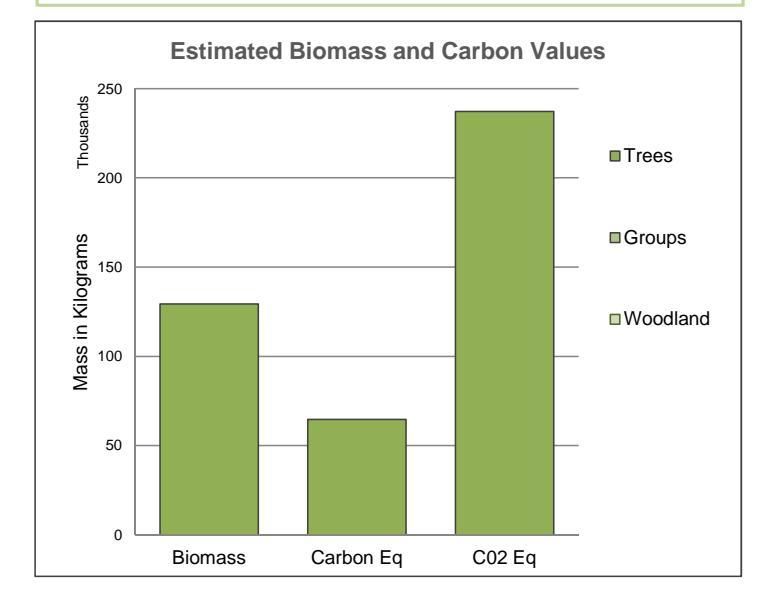
Estimated Biomass and Carbon Values presents the values calculated from the trees, groups and any woodlands where present. A comparison can be drawn from the values and any proposed removals compared with mitigation planting and the potential carbon sequestration.

**Biomass** is the total mass of all living material within the trees present on site. The biomass of the tree stock has been calculated using allometric equations derived from peer reviewed papers. For the purposes of the calculations hedgerows have not been included due to a lack of research currently in this field.

The **Carbon Equivalent** is half the biomass dry weight and represents the weight of the carbon equivalents present in the tree stock.

**Carbon Dioxide Equivalent** is a conversion of the carbon equivalent to a theoretical weight of carbon dioxide which could be released from the tree stock.

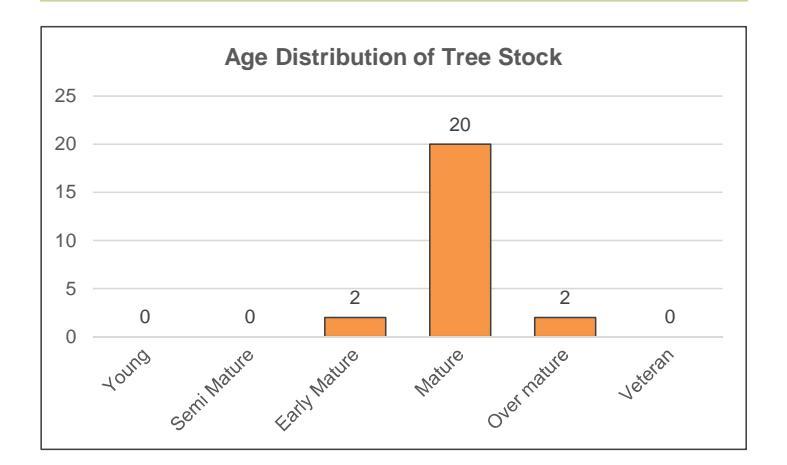
Age Distribution of Tree Stock shows the number of trees in each age category across the tree stock allowing assessment of their longevity to be made.

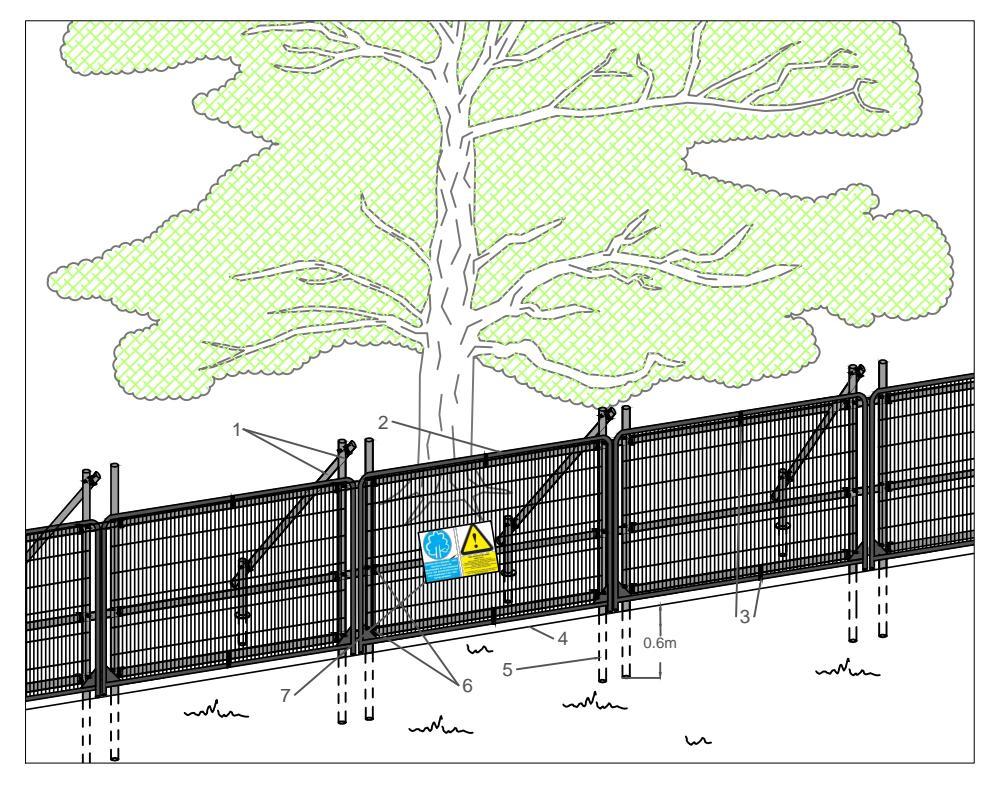
# Standard specification for protective barrier

- 1. Standard scaffold poles
- 2. Heavy gauge 2m tall galvanized tube and welded mesh infill panels
- 3. Panels secured to scaffold frame with wire ties
- 4. Ground level
- 5. Uprights driven into the ground until secure (min depth of 0.6m)
- 6. Standard scaffold clamps
- 7. Construction Exclusion Zone signs

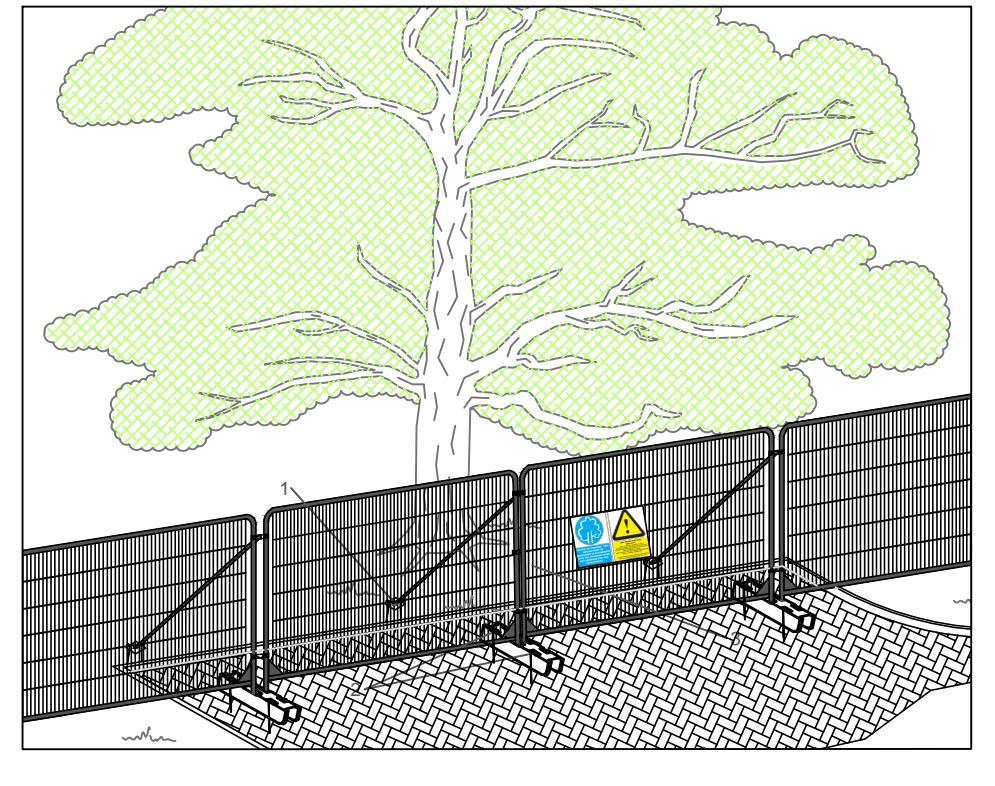
#### Above ground stabilising systems

- 1. Stabiliser strut with base plate secured with ground pins
- 2. Feet blocks secured with ground pins
- 3. Construction Exclusion Zone signs
