Report Date October 2013 Shelwick, Old Farm House Preliminary Ecological Survey

Shelwick, Old Farm House Preliminary Ecological Survey Autumn 2013

Client: Mr. & Mrs. Millington

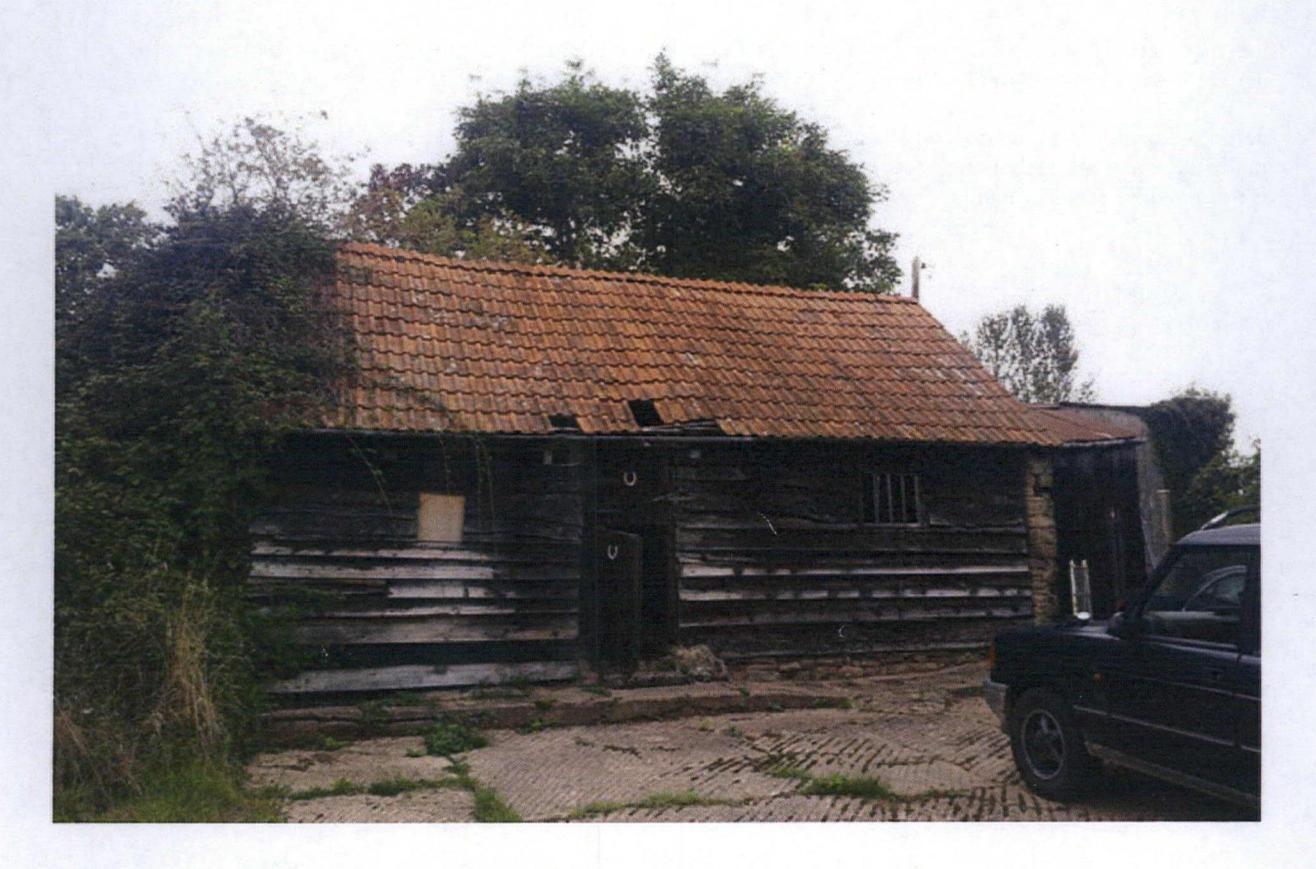
Barn seen from the South

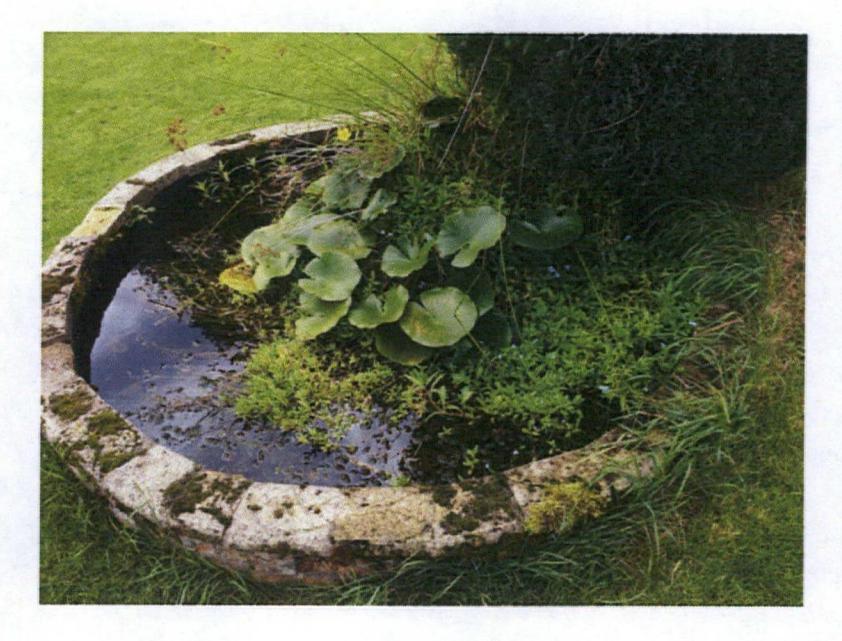
Photo 3. Small ornamental pond

6. Two ponds were found within the garden, the first, a small (approx. 1m diameter), circular, slightly raised ornamental pond with dense pondweed and little open water was located toward the far end of the lawned area to the north of the site. The pond was at the base of an ornamental conifer (Photo 3.).

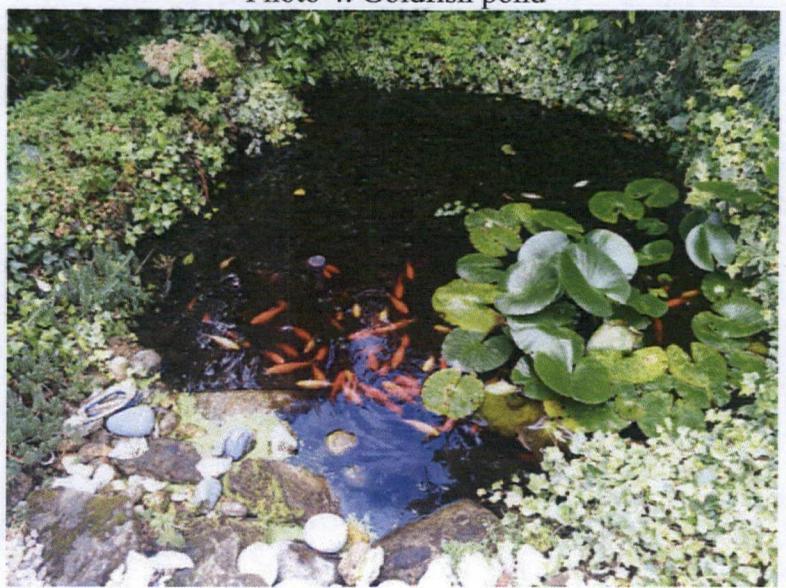
Photo 4. Goldfish pond

7. The second pond was slightly larger (approximately 1.5m in diameter), and densely stocked with goldfish. This was surrounded by flowerbeds, rockery plants and shrubs. It was located to the east of the house and was densely shaded (Photo 4.). This corner of the garden appeared suitable as a terrestrial foraging area for amphibians.

- **10.** The larger pond, stocked with many goldfish was deeper and less densely vegetated and is similarly not considered suitable as a GCN breeding pond, largely due to the high numbers of fish present.
- 11. The "rough" ground to the north of the barn and other outbuildings is considered as potentially suitable foraging habitat for slow-worms but the aspect (north facing) tends to suggest that the densely overgrown site to the west and immediately adjacent to the survey site would currently provide superior foraging and resting habitat for this species. The compost heap and north wall of the barn may provide suitable cover for hibernating animals however.
- **12.** Walnut tree, standing to approximately 12m with a canopy extending to a similar diameter

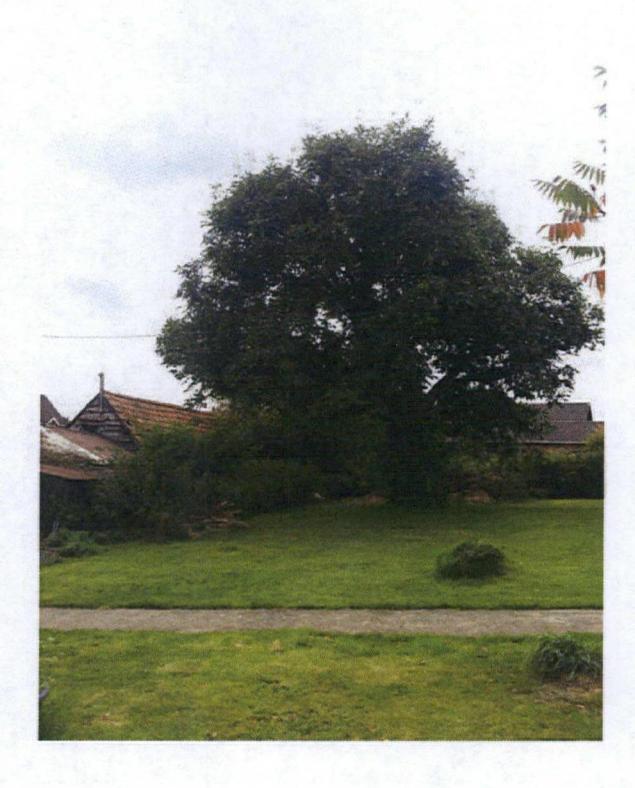
Photo 5. Walnut tree to north of barn.

- 13. The survey was carried out in mid September, no birds were nesting at the time but there were many opportunities on the survey site for nesting birds. The barn itself and the outbuildings showed evidence of previous nesting attempts by Barn Swallow, (*Hirundo rustica*) and, the likelihood of small passerines such as Robin (*Erithacus rubecula*), Wren (*Troglodytes troglodytes*), and Blackbird (*Turdus merula*) nesting in or on these buildings is regarded as high.
- 14. The mature standard Walnut tree (*Juglans regia*) immediately to the north of the barn has numerous dead branches and open cavities. This tree also has the capacity to support a number of nesting bird species during the spring and summer months (Photo 5.).

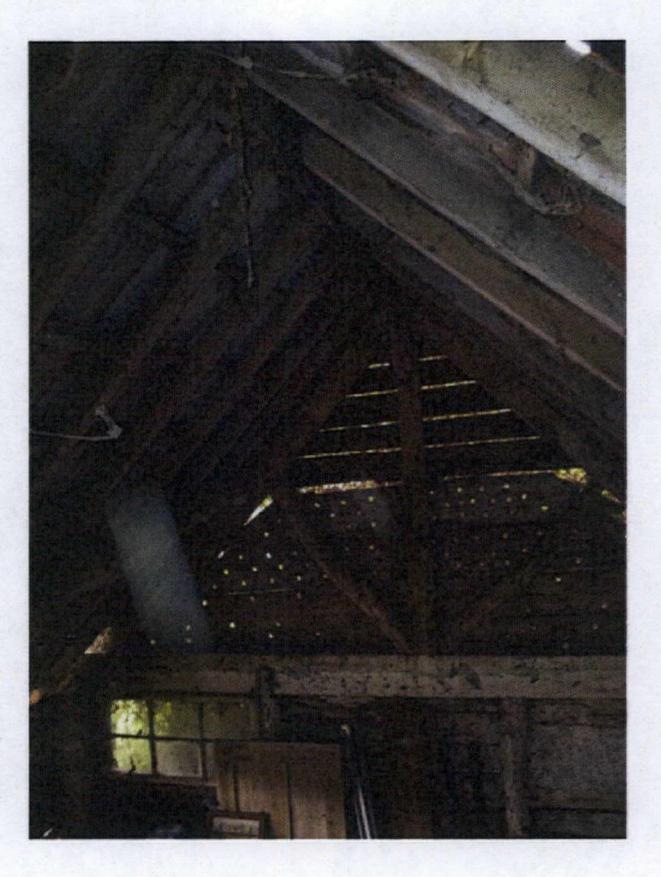
Photo 6. Interior of upper storey

- **15.** The site was initially visited during daylight hours and an intensive inspection of the grounds within the curtilage of the Old Farm House was made with inspections concentrated on potential habitats that may be used by EPS.
- 16. Close inspection was made of the out-buildings for evidence of bats and the potential for nesting bird issues during the spring and summer months. Ladders and high powered lamps were used to investigate roof coverings, and structural timbers (especially joints) from the inside. Surfaces were inspected for bat droppings and gaps and holes in the timber were inspected for grease or urine stains that are evident when bats have repeatedly used such refuges. Photo 6 shows the interior of the upper storey viewed from the eastern end.

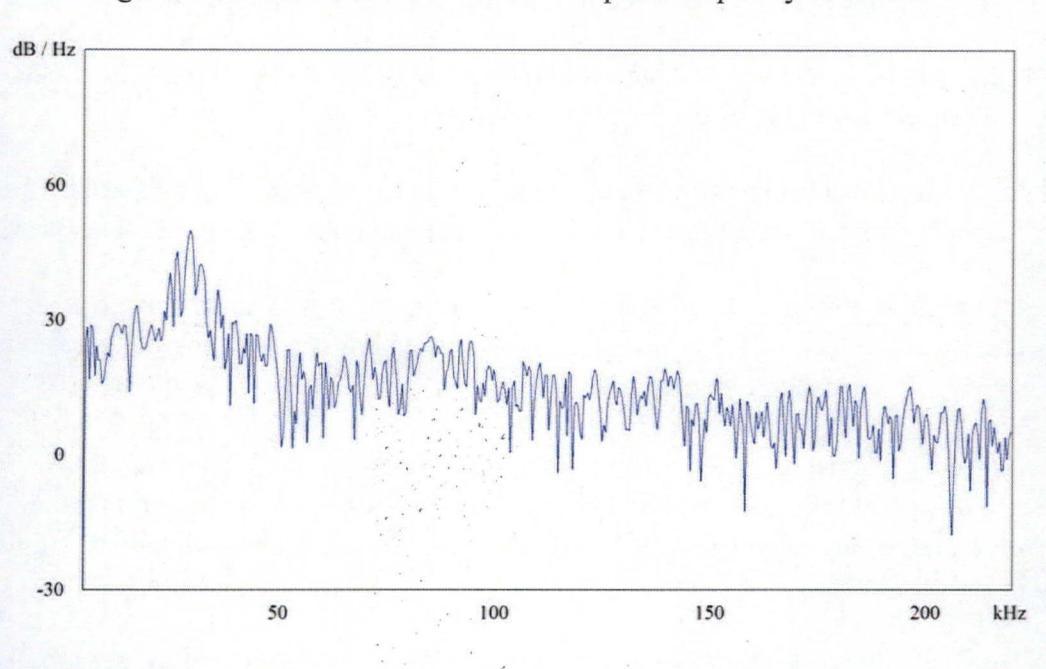
Figure 1: Serotine bat echolocation call peak frequency at 29kHz

- **31.** On the evening of the 20th September sunset was at 19:13hrs.Low frequency calls were heard at 10 minutes prior to sunset from the vicinity of the walnut tree. The bat detector was set to approximately 25 kHz and recordings made of the echo-location calls (See figures 1 and 2) This tree has numerous deadwood and holes in the upper branches. Two large bats with broad wings were observed flying around the walnut tree to the north of the barn and within the garden from 19:18hrs. Flight characteristics were variable with the bats flying above the walnut tree with frequent swoops to ground level and along hedgelines at 1-3m height. They were observed to fly to the west of the site and return frequently sometimes at very low level. Analysis of the recordings made during these flights indicates the probability of these being Serotine bats, *Eptericus serotinus*. No bats were observed leaving the barn.
