BAT ROOST ASSESSMENT

Moorhampton House Barn, Hereford, HR4 7BE

A bat roost assessment undertaken for Moorhampton House Barn, Hereford, for the proposed conversion of the barn from agricultural to residential use.

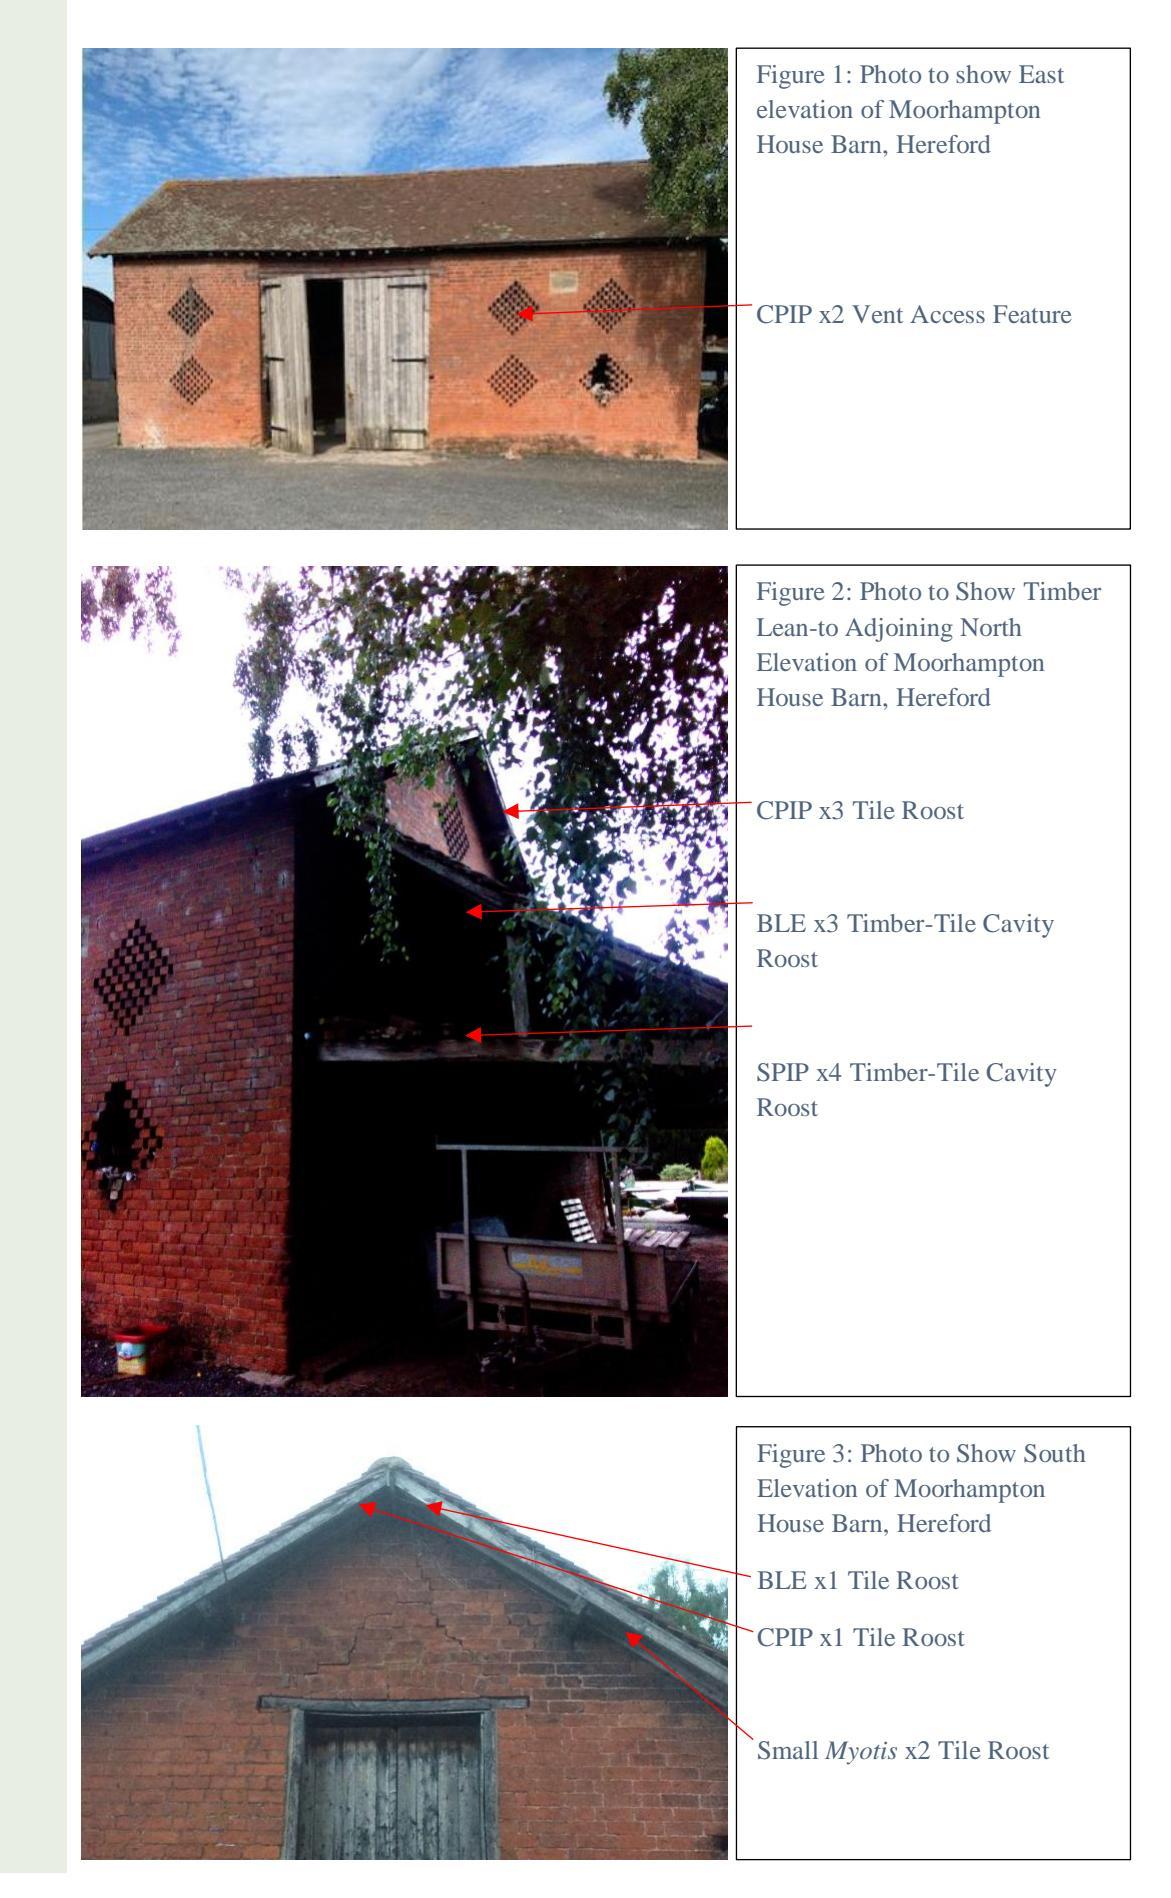
Survey	Species	No.	Elevation	Feature	Figure
15.07.19	CPIP	1	S	Edge tile gap	3
15.07.19	BLE	1	S	Edge tile gap, gable end, ridge/apex	3
30.07.19	SPIP	4	Ν	Lean-to, timber-tile crevice	2
30.07.19	Myotis	2	S	Gable end, edge tile gap	3
30.07.19	CPIP	2	S	Edge of tiles and mortar/brick feature	3&4
30.07.19	SPIP	1	S	Gable end, edge tile gap	3
30.07.19	BLE	1	S	Edge tile gap, gable end, ridge/apex	3
19.08.19	SPIP	4	Ν	Lean-to, timber-tile crevice	2
19.08.19	BLE	3	Ν	Lean-to, timber-tile crevice	2
19.08.19	CPIP	3	Ν	Gable end ridge, edge tile gap	2
19.08.19	CPIP	2	E	Constructional vent, access to timbers	1
19.08.19	CPIP	2	S	Edge of tiles and mortar/brick feature	3 & 4
19.08.19	BLE	1	S	Edge tile gap, gable end, ridge/apex	3

- 5) As compensation for the loss of the Brown Long-Eared timber roost feature in the North elevation adjoining lean-to, a bat loft with integrated crevice features will be created within the proposed loft void within the lean-to with bat access feature from the East elevation.

- 6) As compensation for the loss of the Soprano Pipistrelle timber roost feature in the North elevation adjoining lean-to, a shallow bat loft with integrated crevice features will be created within the apex of the main part of the barn and will span the full length of the building with bat access features from the North and South elevations.

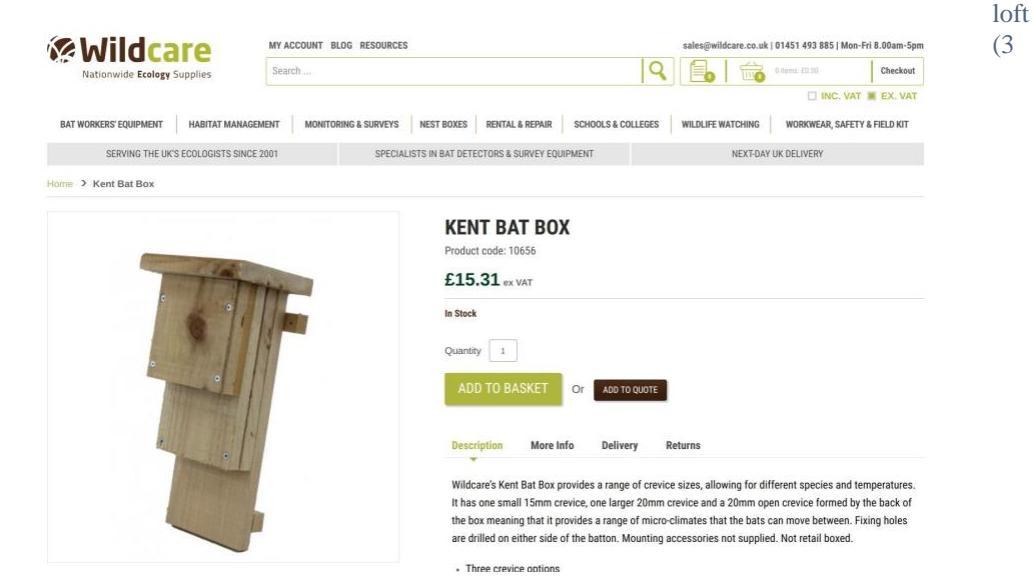
Kent bat box for use during destructive search - to be recycled and used as crevice features in

total):

- 4) Prior to the commencement of works four bat boxes (details in Appendix 3) shall be installed on the mature Birch to the North of the barn and on the Dove Cote building to the South, to receive bats removed during the destructive search.

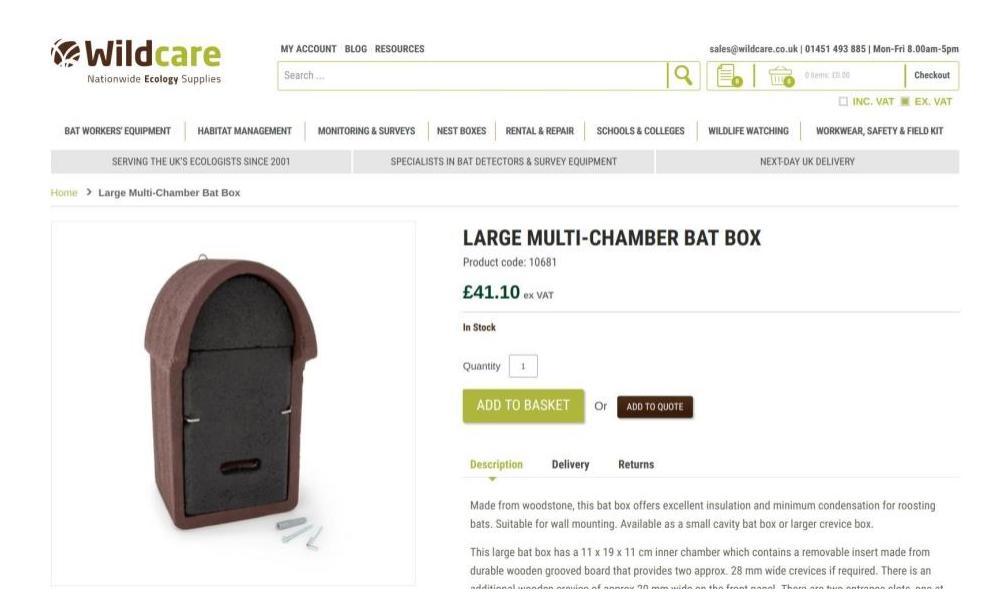
Woodstone Cavity bat box for use for BLE during destructive search – to be recycled and used as crevice feature in loft (1 total – chambers to be removed):

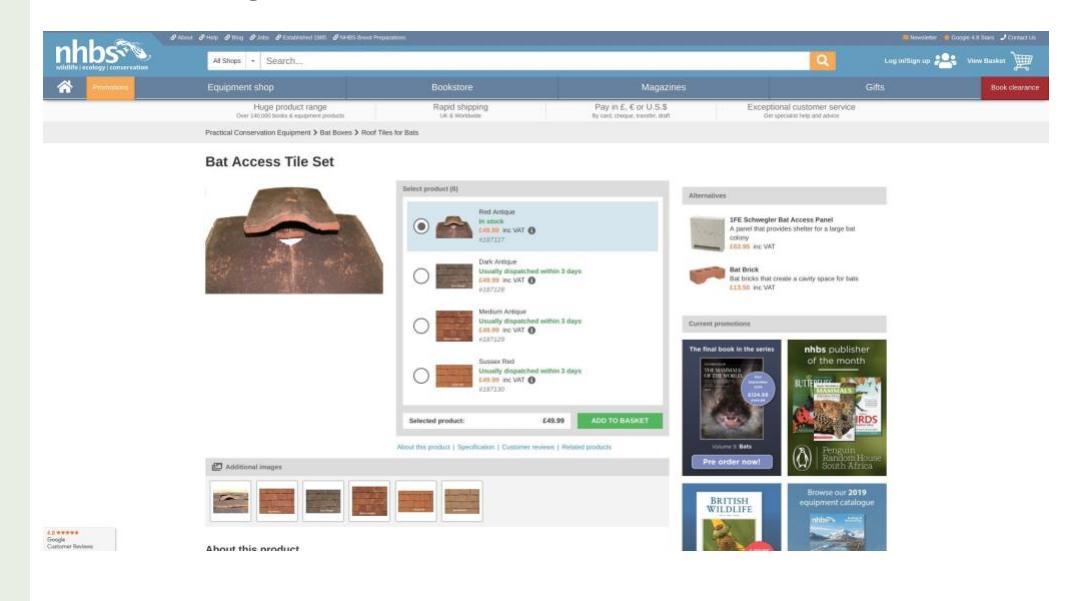
Bat access tile to replace tile roosts (4 total):

- 1) As compensation for the loss of the Common Pipistrelle tile roost on the North elevation two bat tiles will be installed at the edge of the roof on each pitch at the Northern end.

- 2) As compensation for the loss of the small *myotis* tile roost and Common Pipistrelle tile roosts on the South elevation two bat tiles will be installed at the edge of the roof on each pitch at the Southern end.

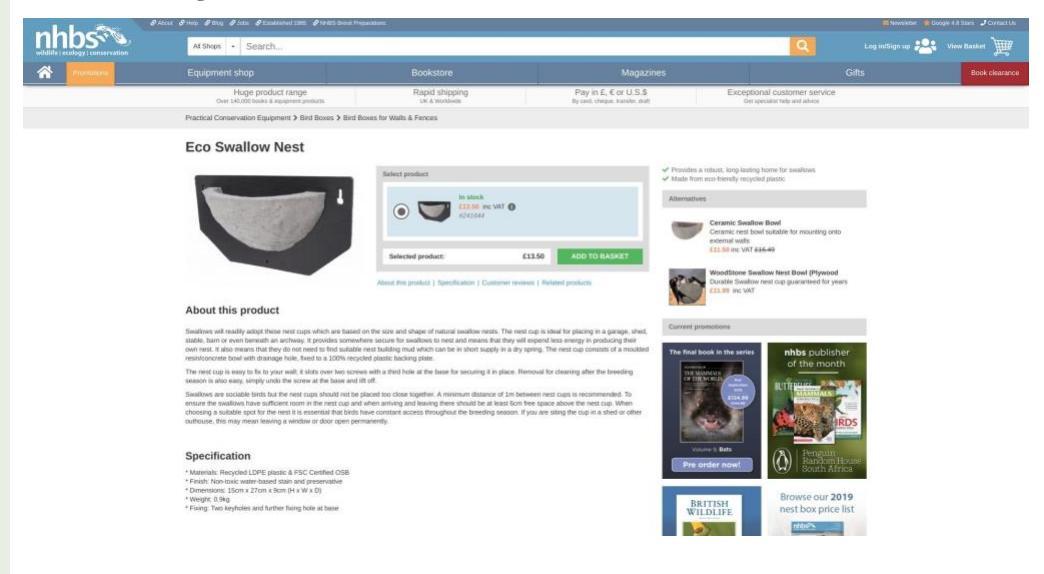
Swallow nest cups to be installed on East elevation (2 total)

- 8) As compensation for the loss of Swallow nesting habitat, two artificial Swallow nest cups shall be installed on the East elevation beneath the roof overhang.
