Herefordshire Council

Model Farm

Geotechnical Update to Desk Study (2008), Phase 1 Environmental Risk Assessment (2008) and the Ground Investigation Report (2009)

Technical Update Report

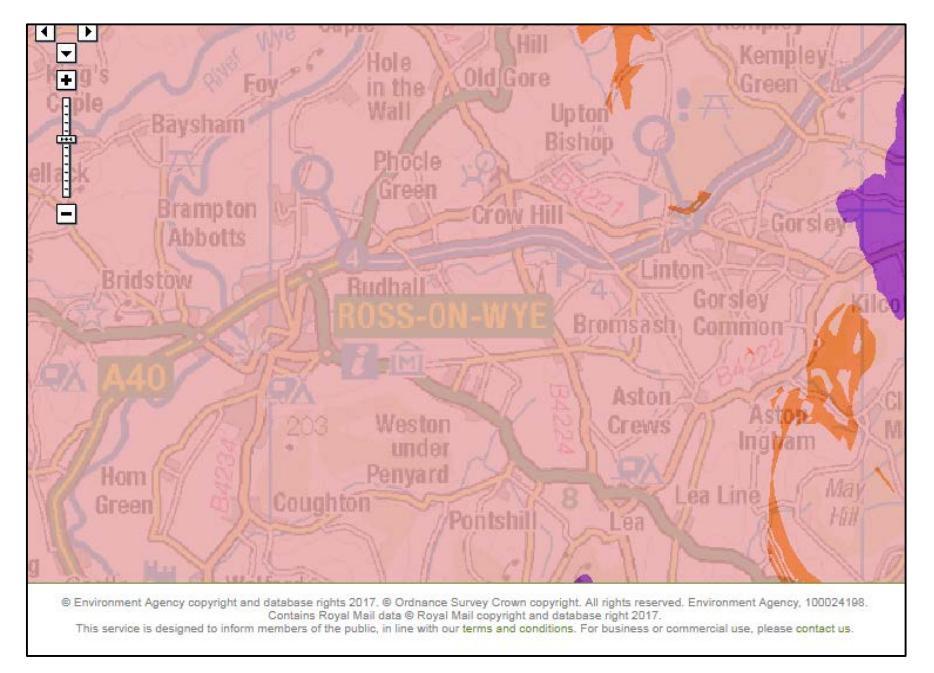
The bedrock geology of the site (Brownstones Sandstone Formation) is also classified as a Secondary A aquifer (http://maps.environment-agency.gov.uk/) as shown on Figure 3.

Figure 3 Bedrock Aquifer designation: Secondary A aquifer (<u>http://maps.environment-agency.gov.uk/</u>)

The bedrock and superficial aquifer classifications beneath the Model Farm site have however been updated and should now be regarded as Secondary A Aquifers; these were formerly known as minor aquifers.

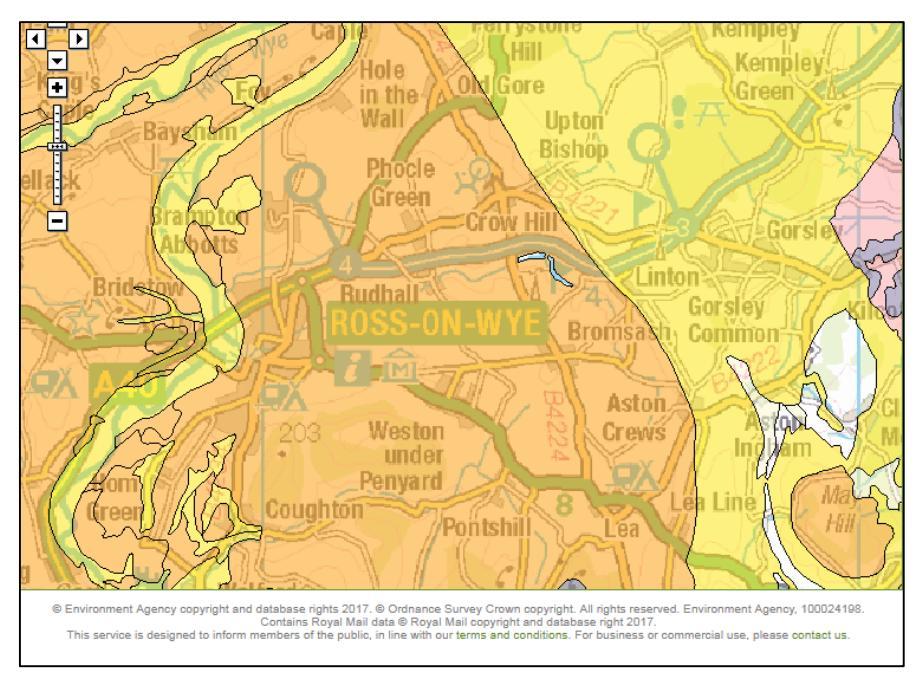
capability and understanding of the factors affecting vulnerability. Figure 4shows that the site is located within a Major Aquifer Intermediate Groundwater Vulnerability Zone, with soils of intermediate leaching potential.

Figure 4 Groundwater Vulnerability zone; Major Aquifer Intermediate (soil leaching) (<u>http://maps.environment-agency.gov.uk/</u>)

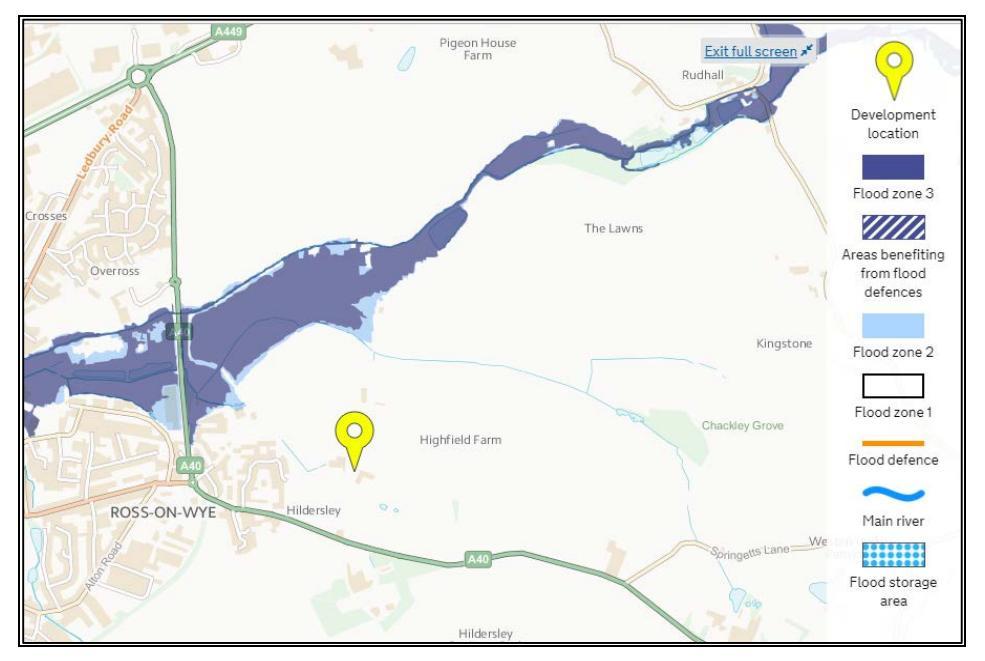
• Review of the Environment Agency's Flood Map for Planning data (Rivers and Sea) (Figure 5) shows the site to be located in 'Flood Zone 1': having a low probability (less than 1 in 1000 annual probability) of river or sea flooding.

Figure 5 Flood Zone 1: Land and property in flood zone 1 have a low probability of flooding (<u>http://maps.environment-agency.gov.uk/</u>).

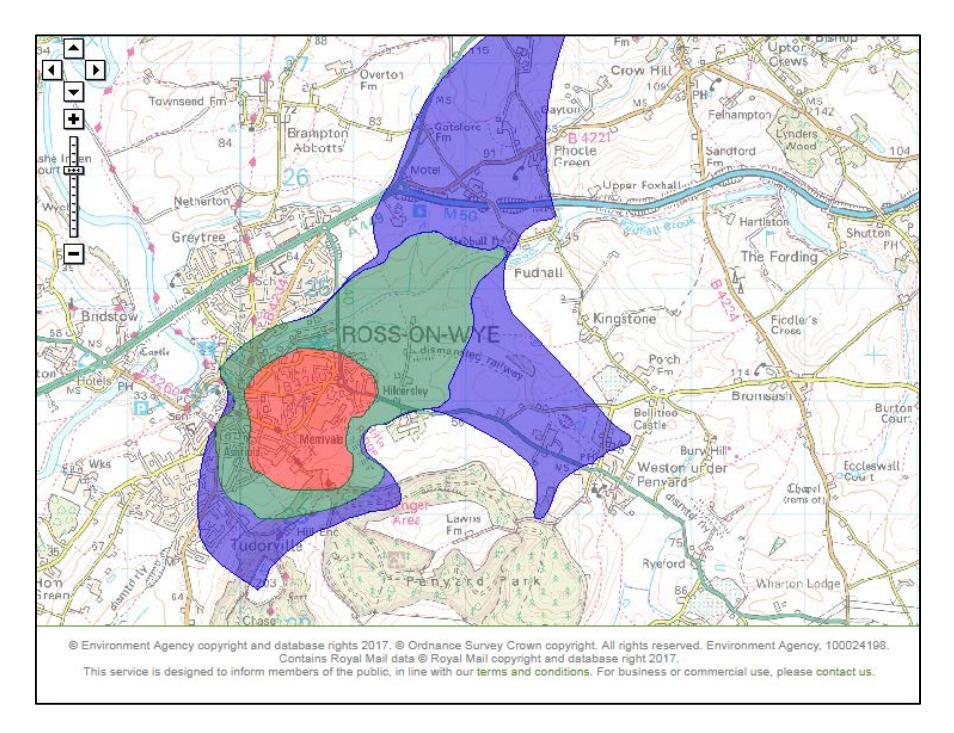
• Concurrent with the 2008 Desk Study report, the site remains within a Groundwater Source Protection Outer Zone (Zone 2) of the Alton Court aquifer (defined as having a 400 day travel time from a point below the water table) as shown in Figure 6.

Figure 6 The Site (approximate location shown by the pink circle) is located in a Groundwater source protection Outer Zone (Zone 2) (<u>http://maps.environment-agency.gov.uk/</u>).
