NE08/2252/F

Proposed works at  
1 Filling Bridge Cottage  
Stretton Grandison  
Hereford

Proposed Elevations

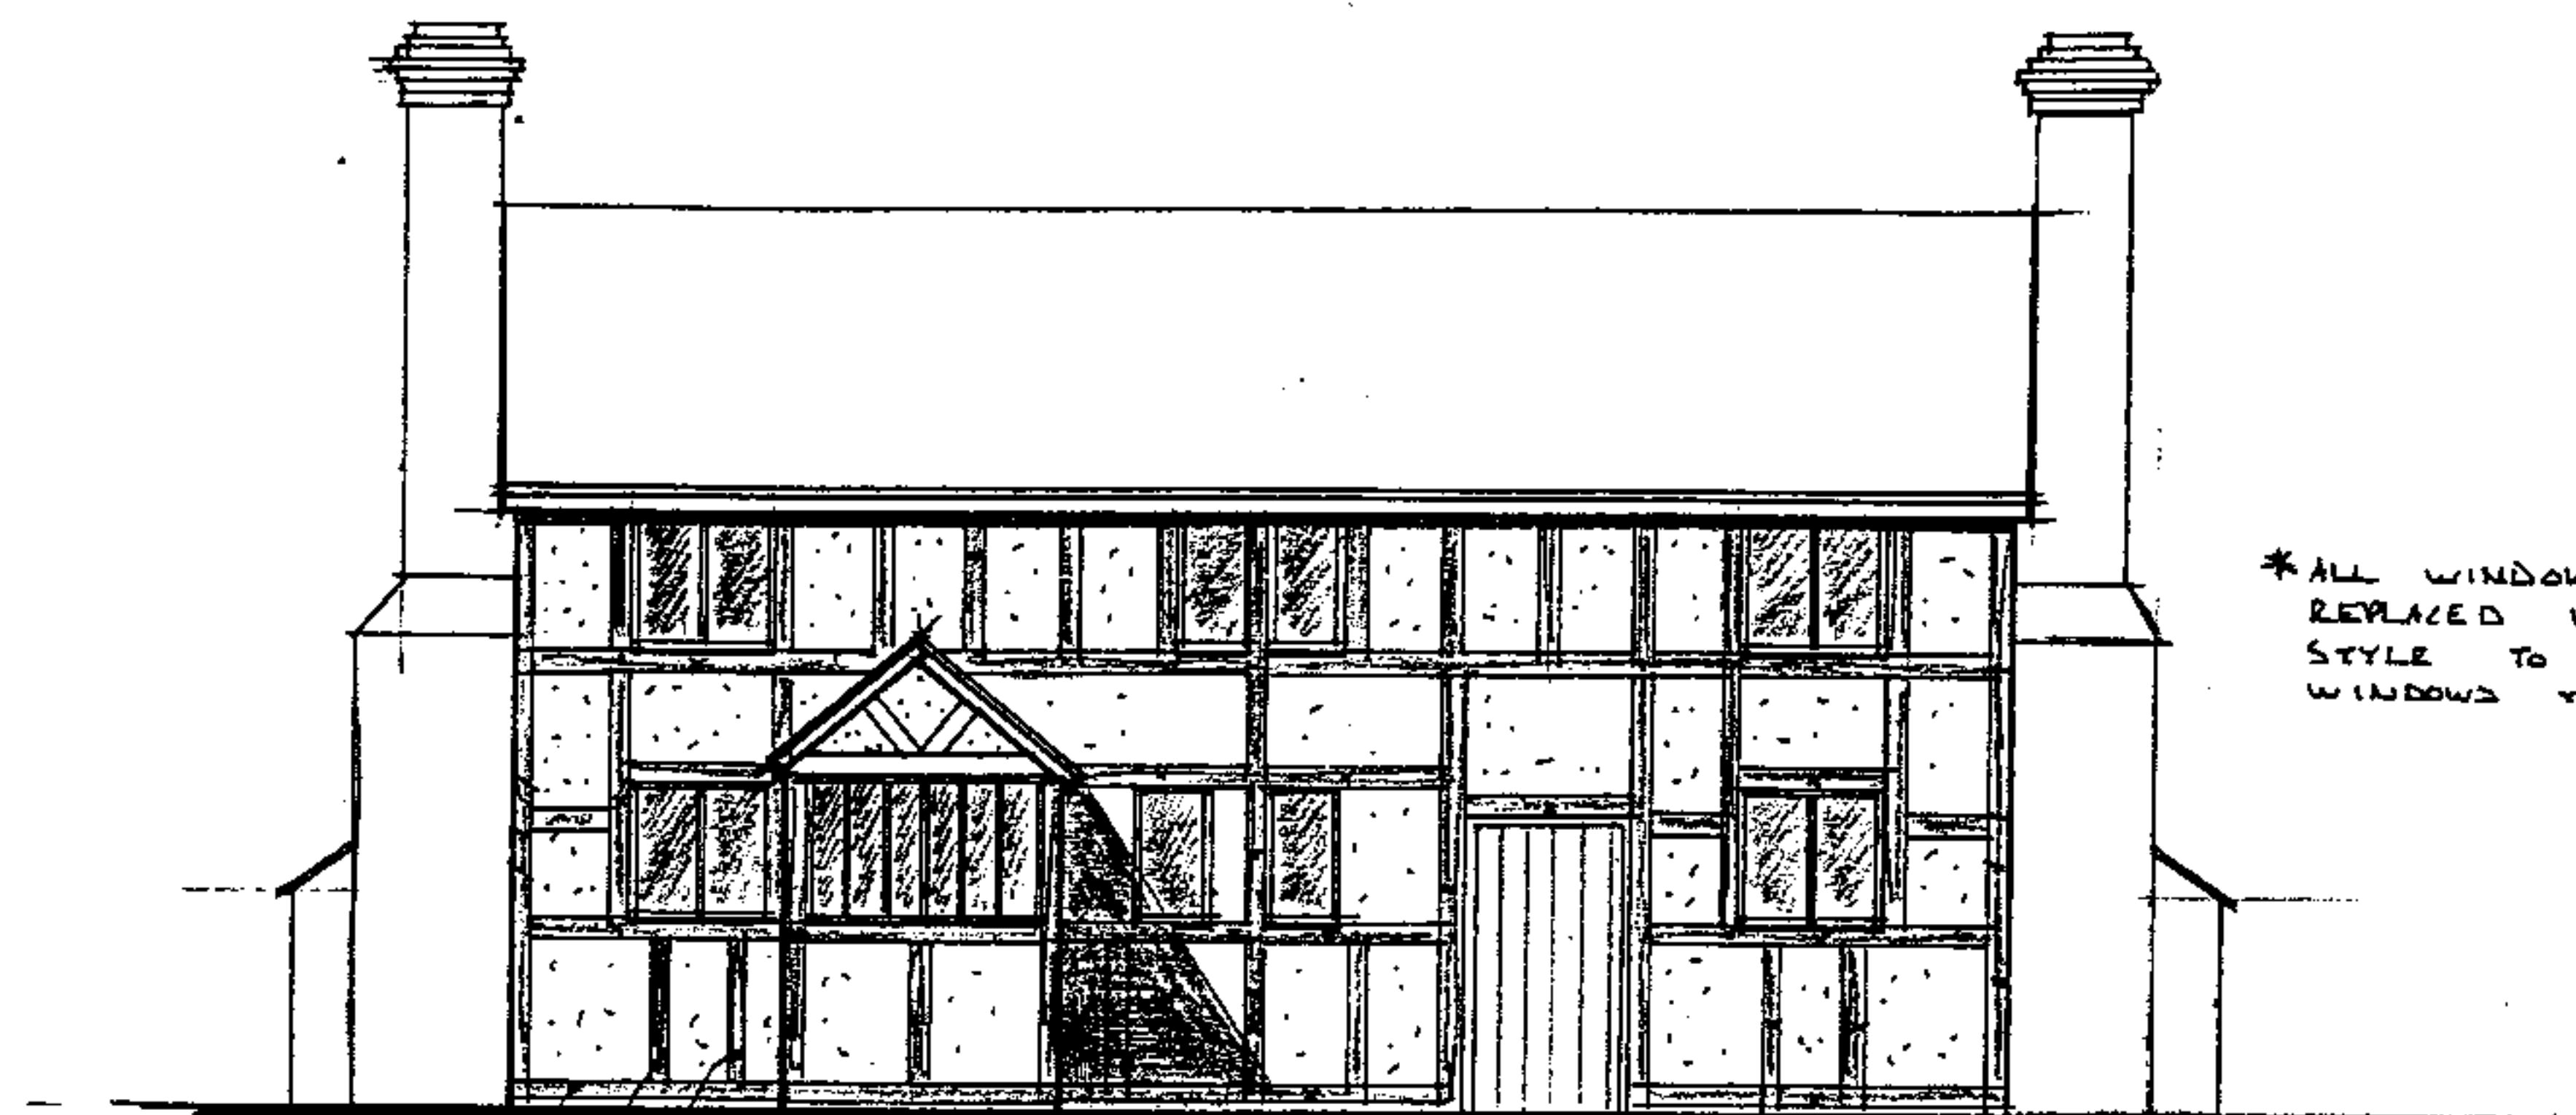
FRONT ELEVATION

RENEW MISSING  
UPRIGHTS &  
PLINTH

REBUILD PORCH

\*ALL WINDOWS TO BE  
REPLACED WITH GLE &  
STYLE TO MATCH EXISTING  
WINDOWS TO BE TIMBER.

NEW LARGE WINDOW

REUSE EXISTING  
SLATES.

OAK POST FRAME.

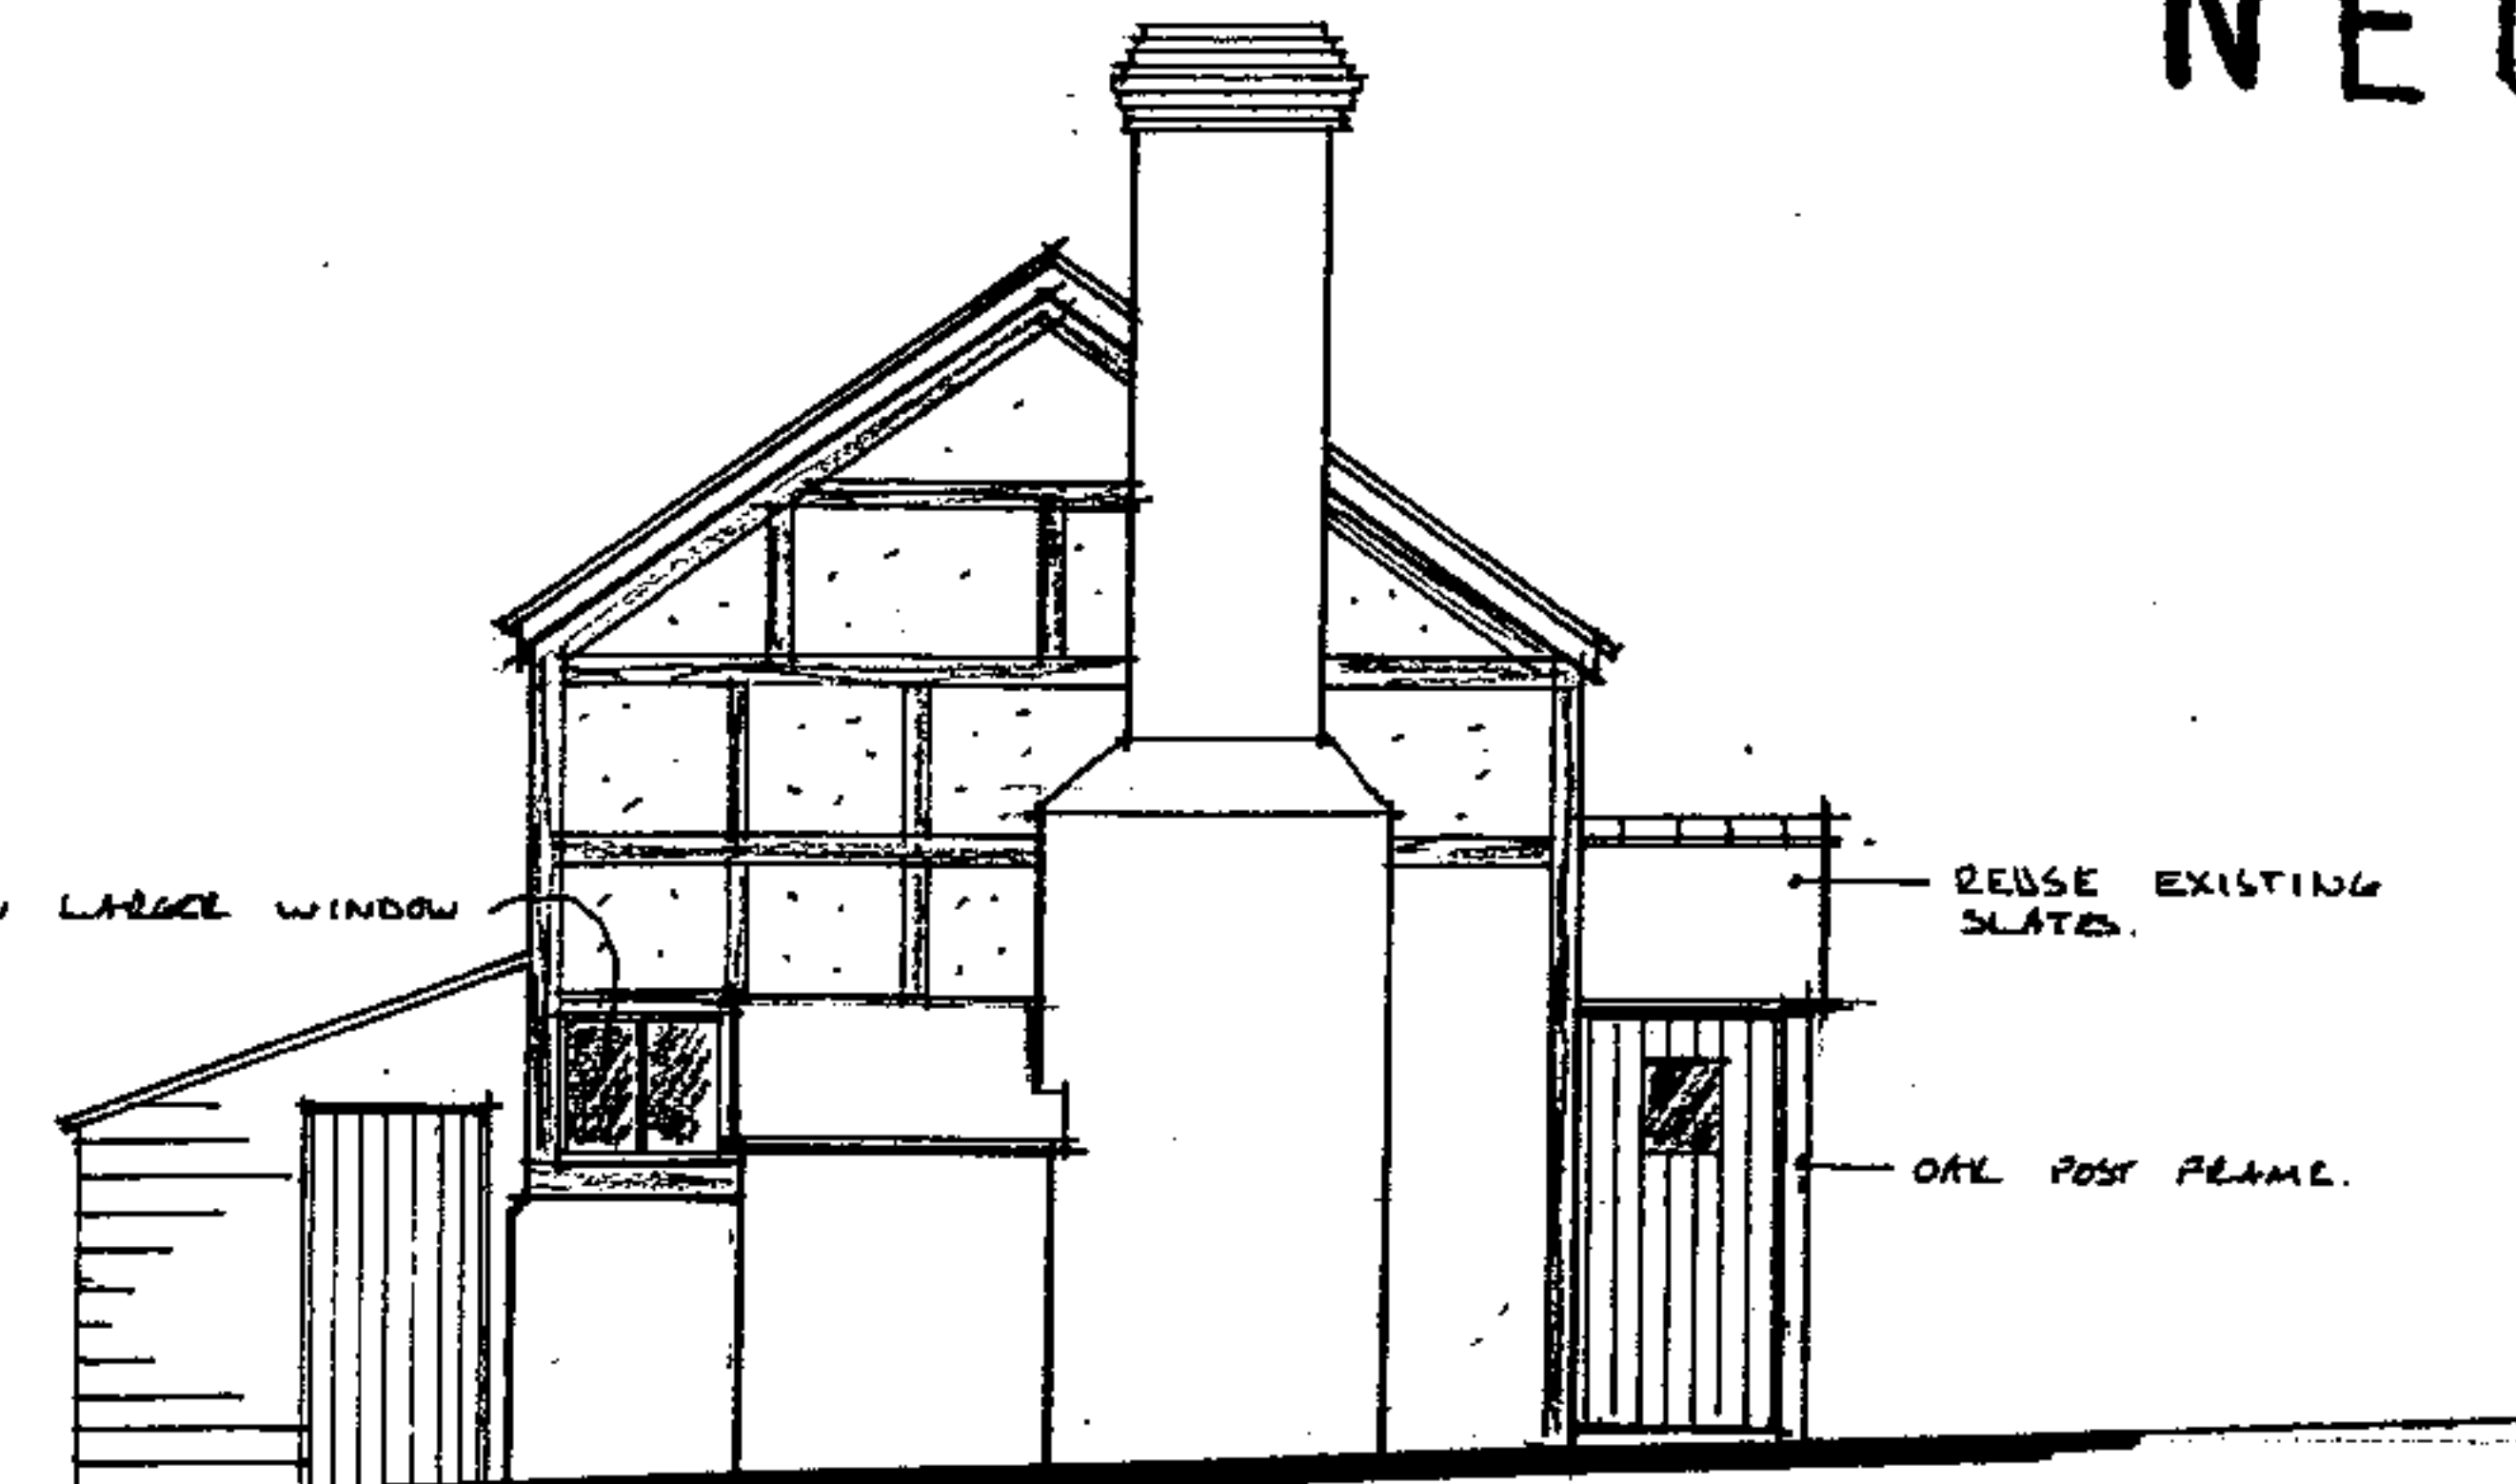
SIDE ELEVATION

\* FRONT FRAME TO BE  
REPAIRED WITH NEW OAK  
MORTICE & TENONED JOINTS.  
SPLICED INTO EXISTING FRAME  
PARTS MARKED RED.

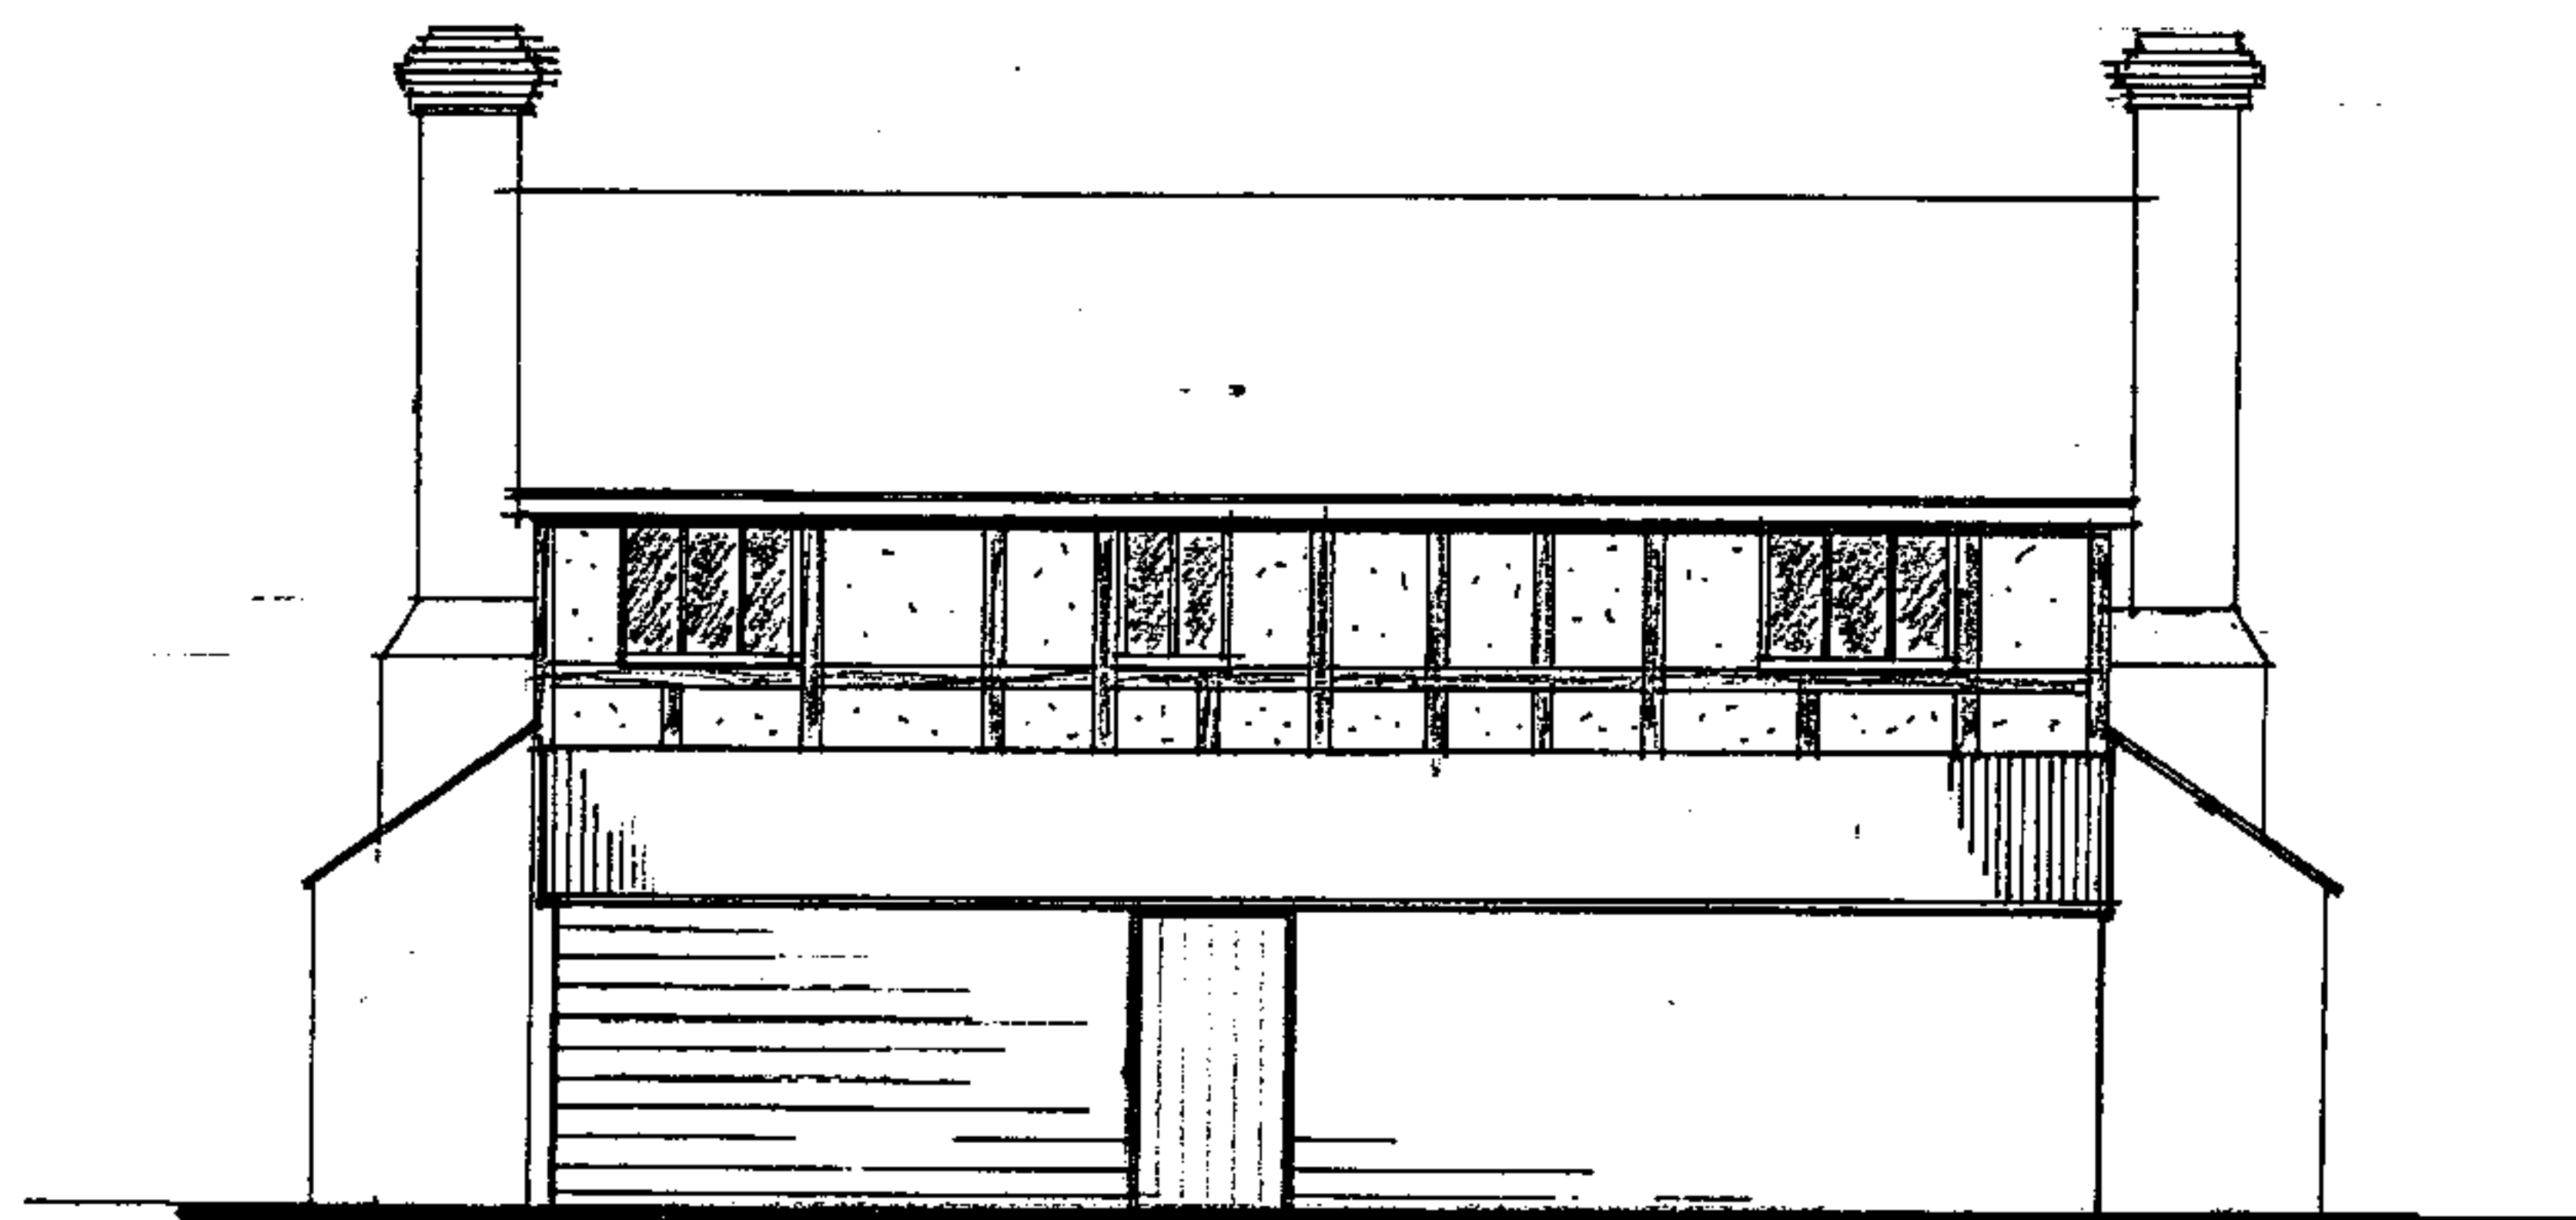
REAR ELEVATION

REBUILD PORCH ON  
ORIGINAL FOOTPRINT.  
OAK POSTS WITH REBUILD  
PANELS.

NEW LARGE WINDOW
