1-2 COMMERCIAL ST  
HEREFORD HR12 2AJ

SKETCH 01 1/120

STRUCTURAL TIMBER REPAIR

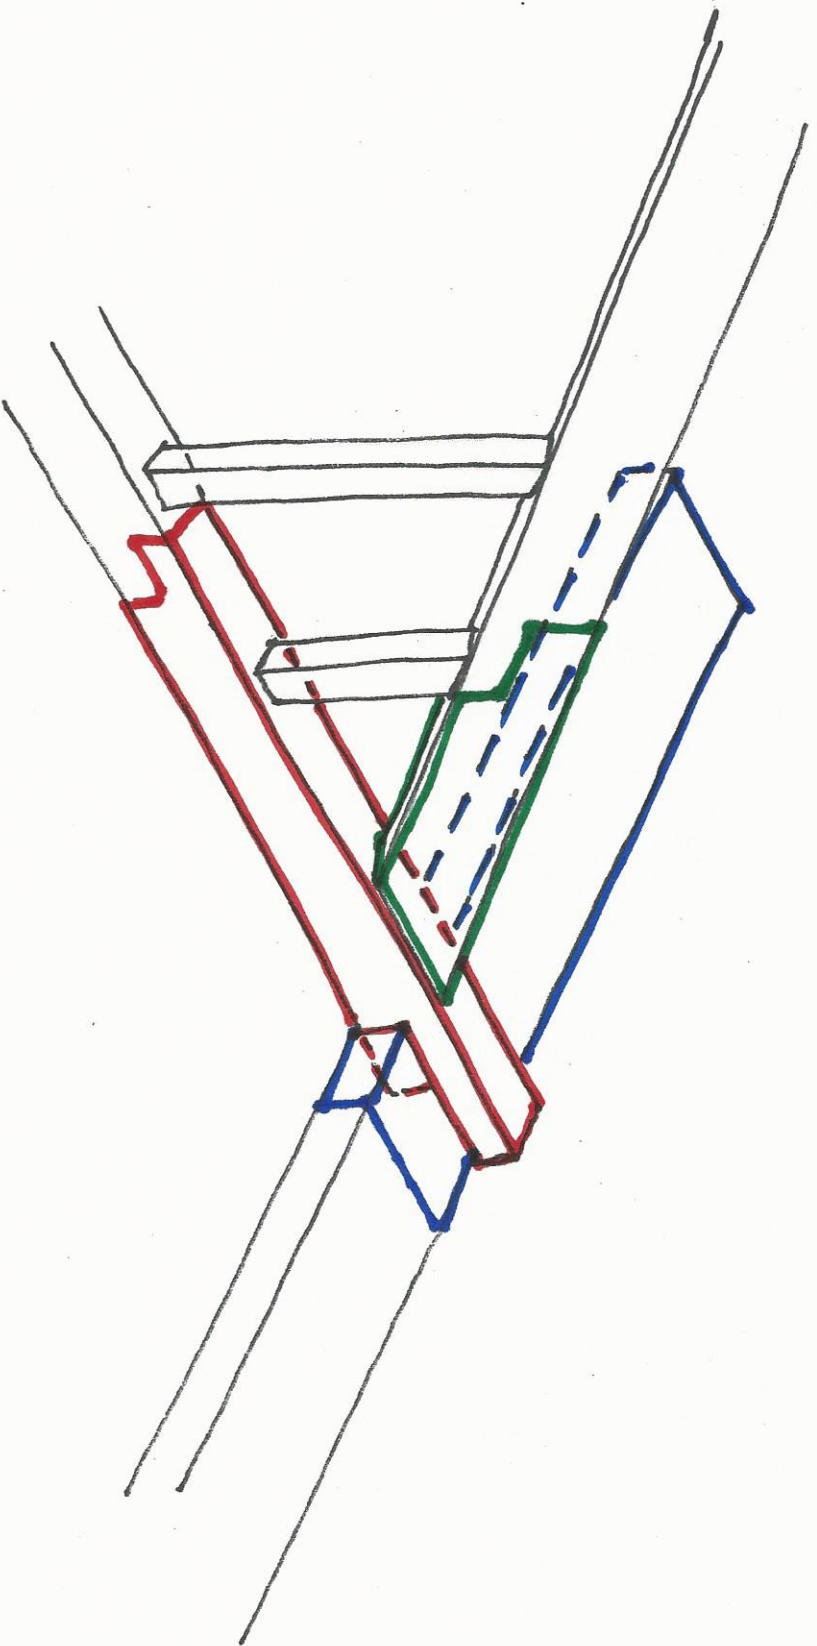
- NEW SECTION OF BEAM
- NEW SECTION OF WALL PLATE
- NEW SECTION OF TRUSS RAFTER

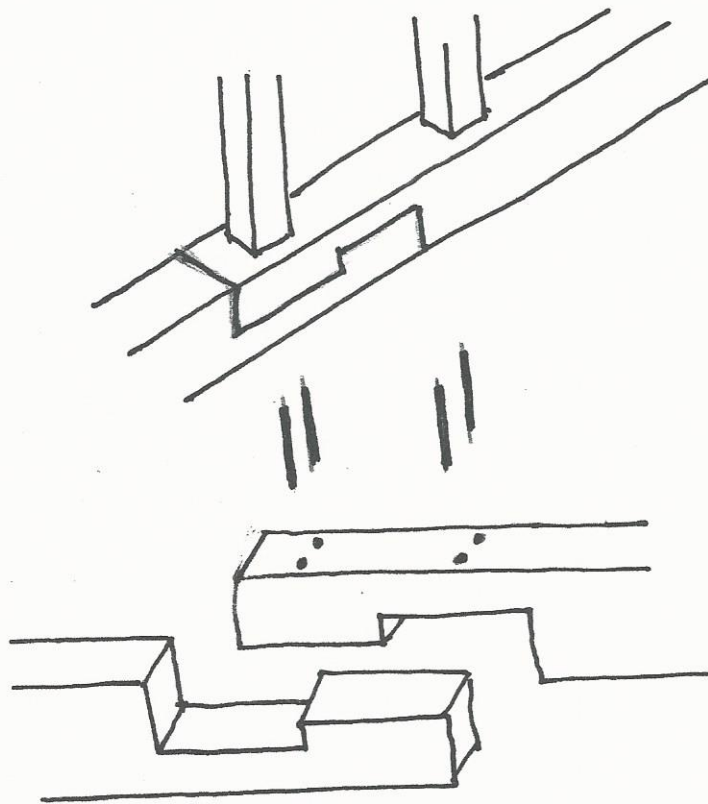
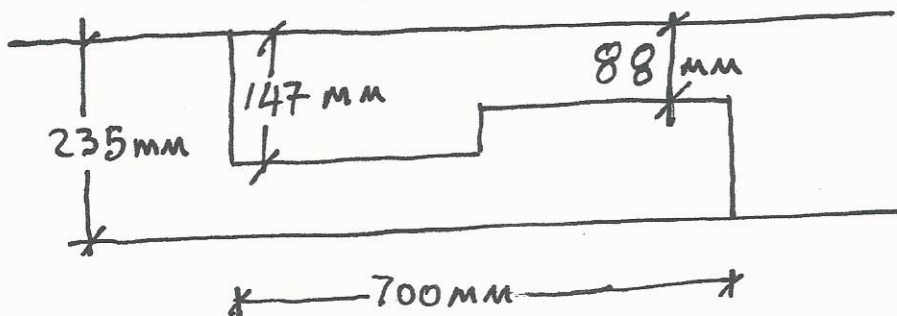
SKETCH 02 NTS

TIMBER REPAIR - TIE BEAM

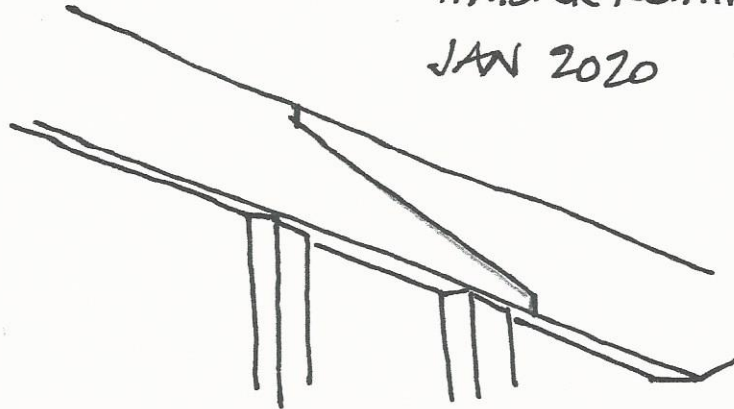
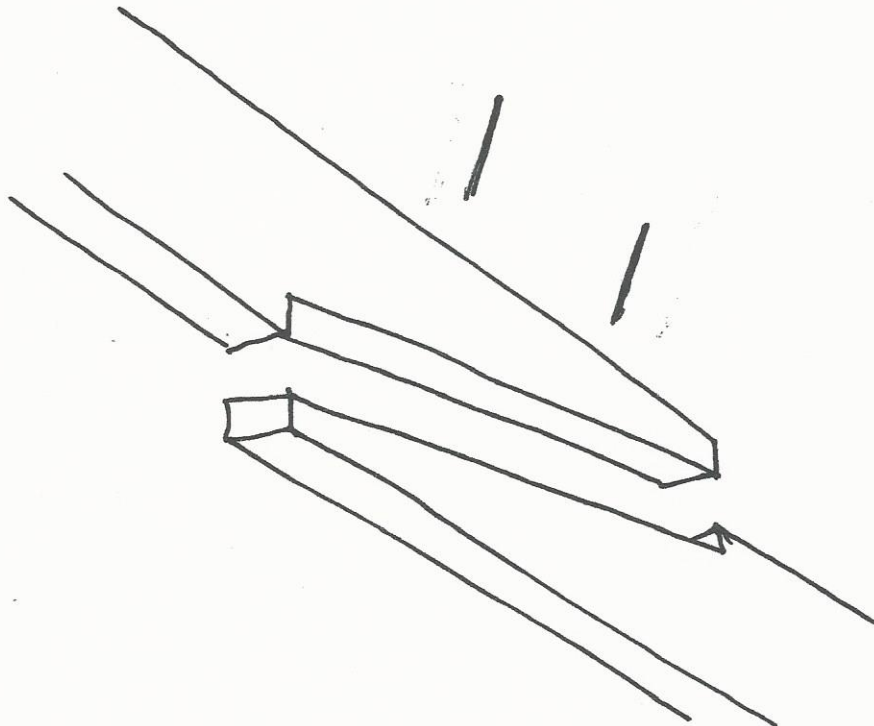
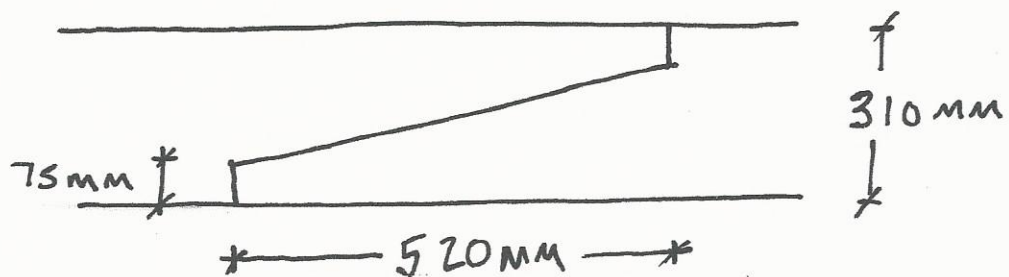
SKETCH 03 NTS

TIMBER REPAIR - RAFTER  
JAN 2020

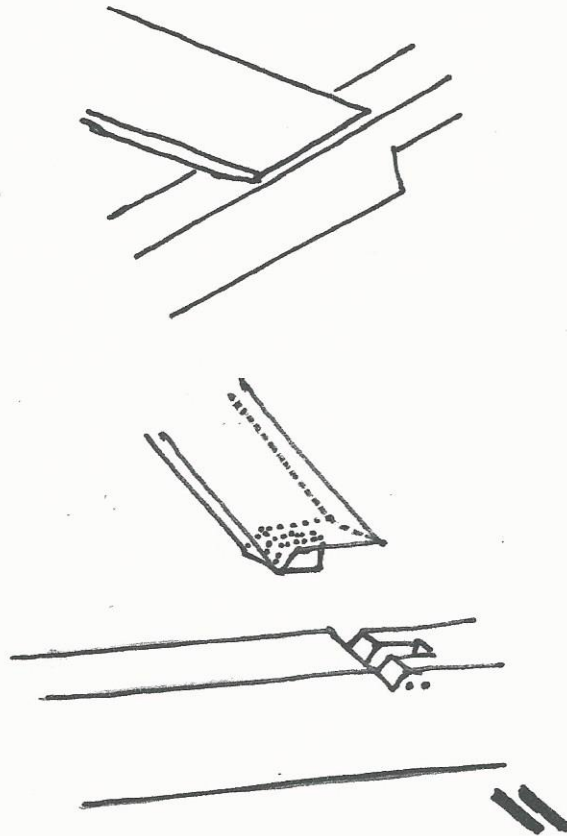
SKETCH 04 NTS

TIMBER REPAIR - RAFTER/TIE BEAM

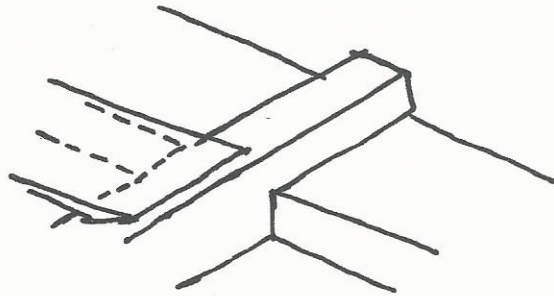
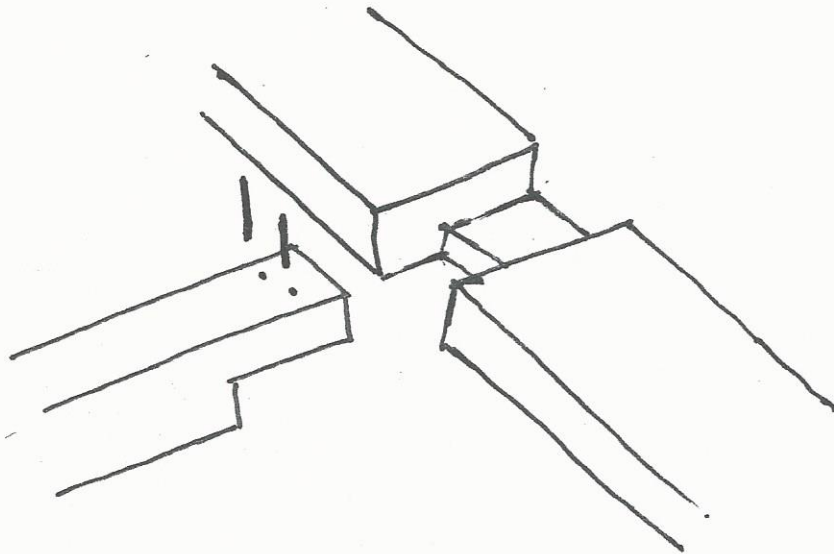
SKETCH 05 NTS

TIMBER REPAIR - TIE BEAM/WALL PLATE

TIE BEAM  
235 MM  
DEEP

WALL PLATE  
125 MM  
DEEP
