Job
BOSBURY
Brook House Farm

East Elevation of Farm House As
Proposed

Drawing No.
H2551/1/135A

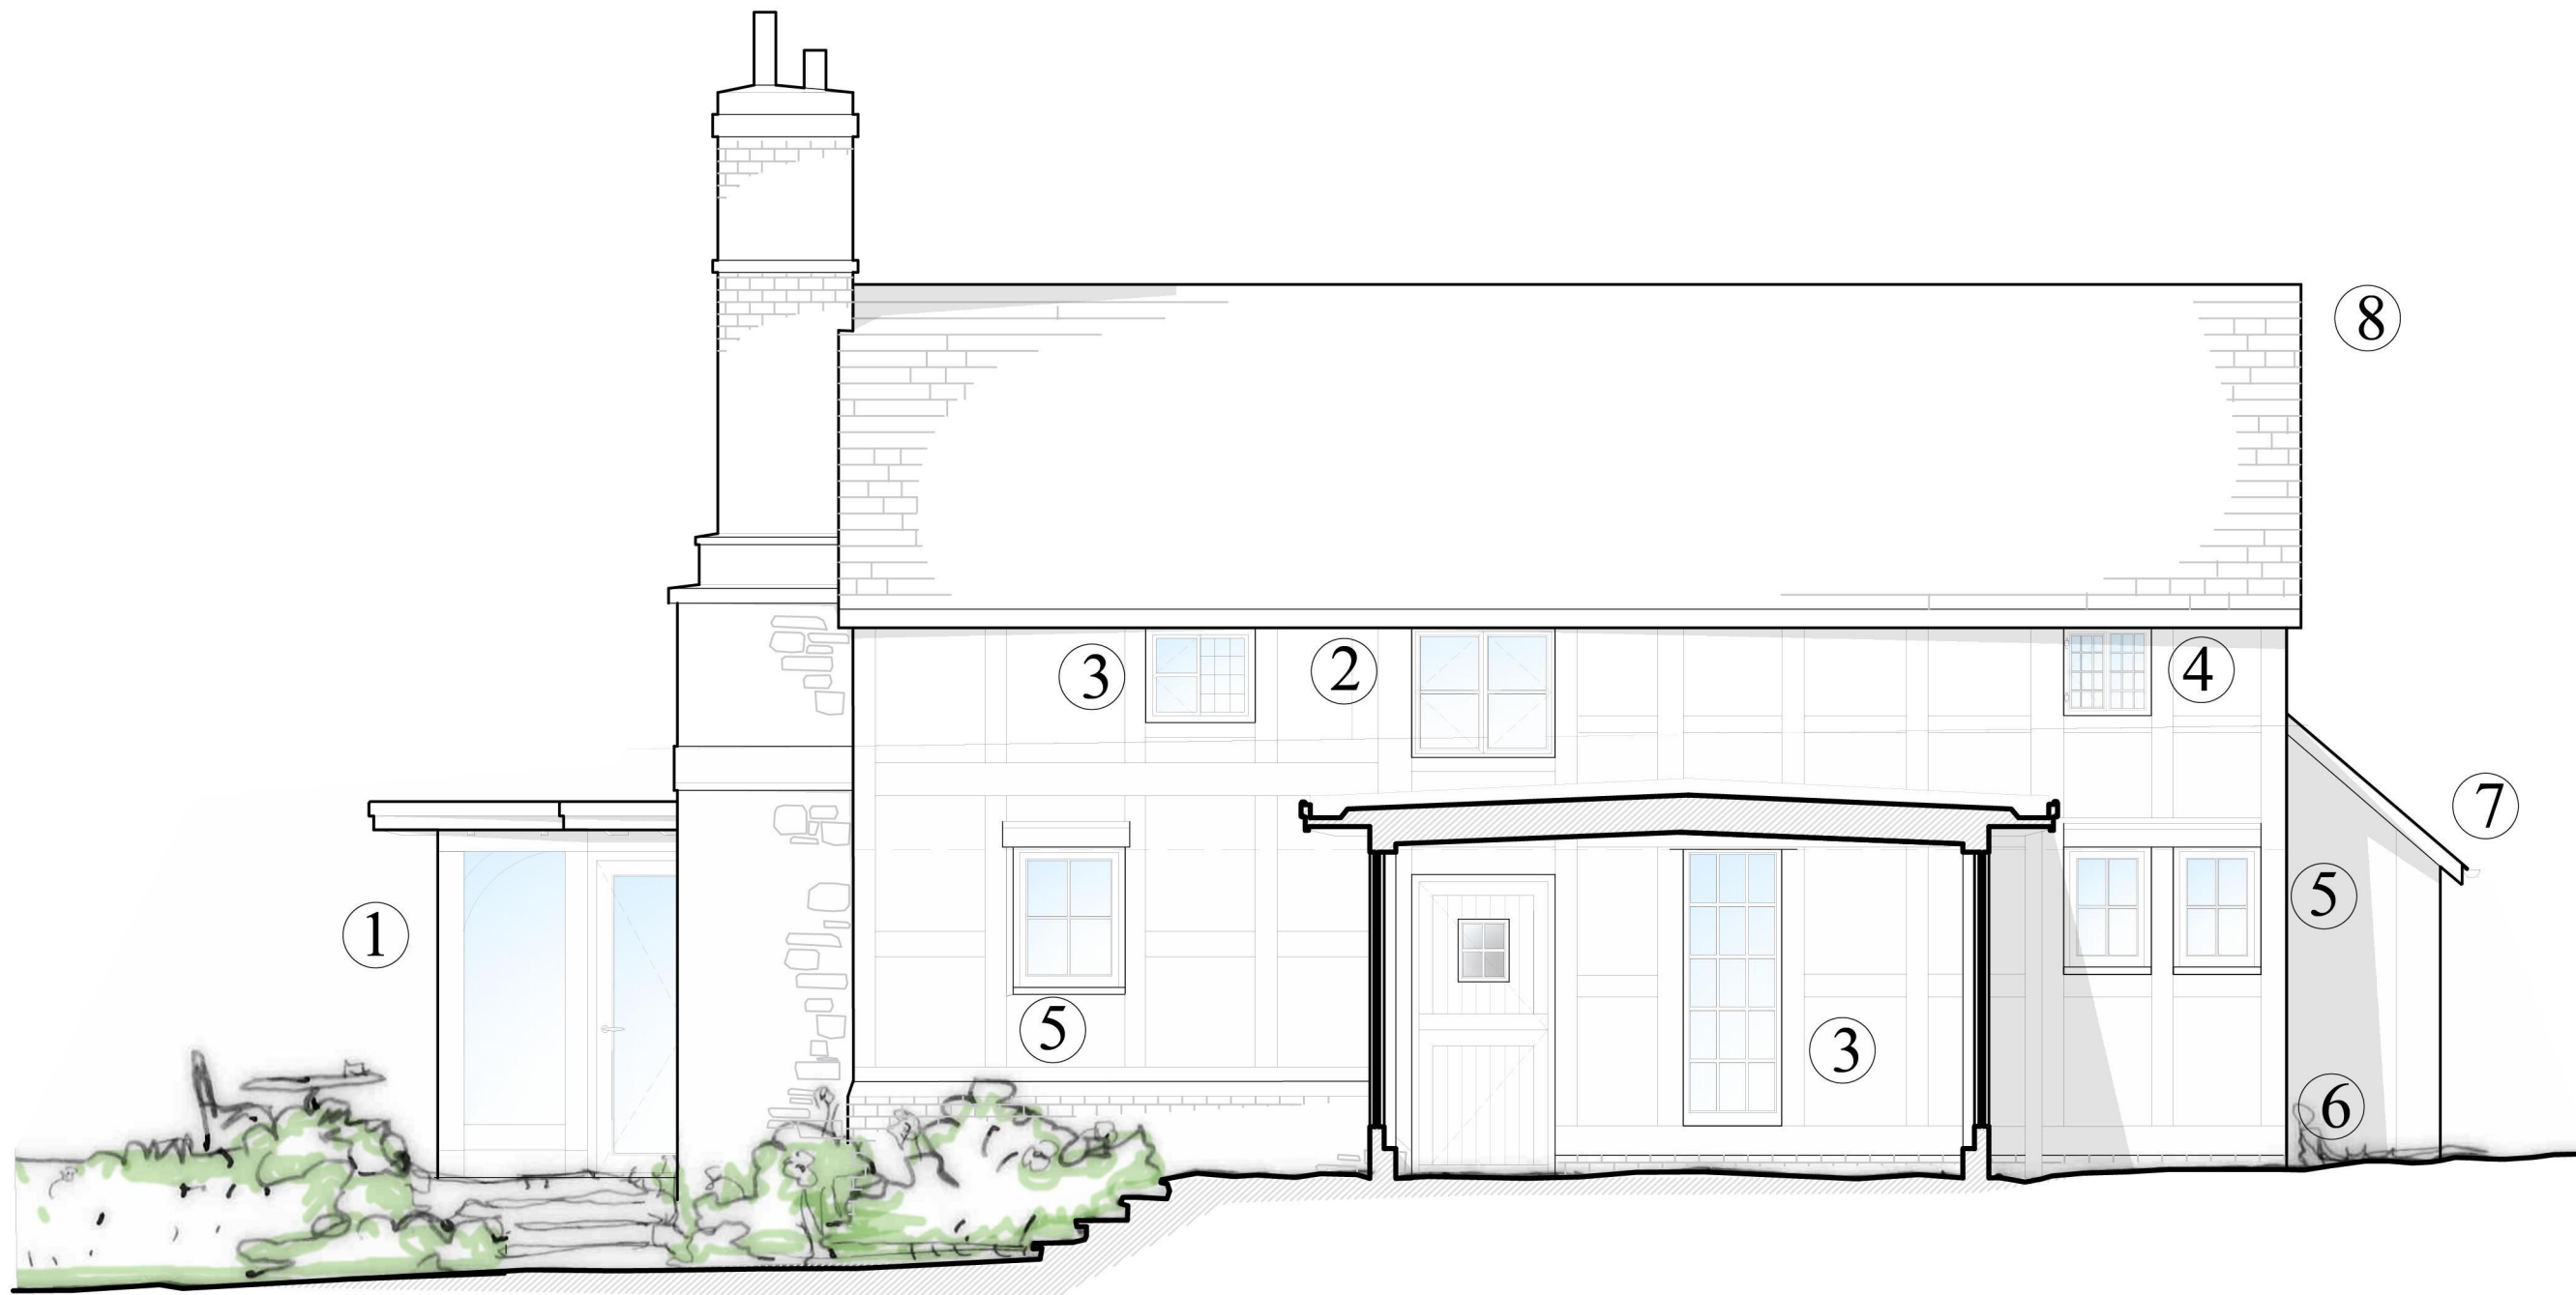
① New green oak framed garden room.

② Repair softwood painted window and reconfigure to remove central mullion for large uninterrupted opening. (For escape)

③ Softwood painted windows to be stripped and restored, oiled internally and white stained externally.

④ Redecorate metal casement window

⑤ Softwood painted windows to be stripped and restored, oiled internally and white stained externally. Replaced weathering detail in lead faced canopy.

⑥ Reinstall rotted out post and sole plate ends.

⑦ Re-roof existing cupboard extension in clay tiles to match existing.

⑧ Remove existing brick chimney serving AGA
