SITE ADDRESS: BAGE MILL  
MADLEY,  
HEREFORDSHIRE.  
HR2 9JP

DWG No: 1953 512

Status: PLANNING

Drawing title: **FRAME SURVEY**  
GENERAL REPAIR DETAILS

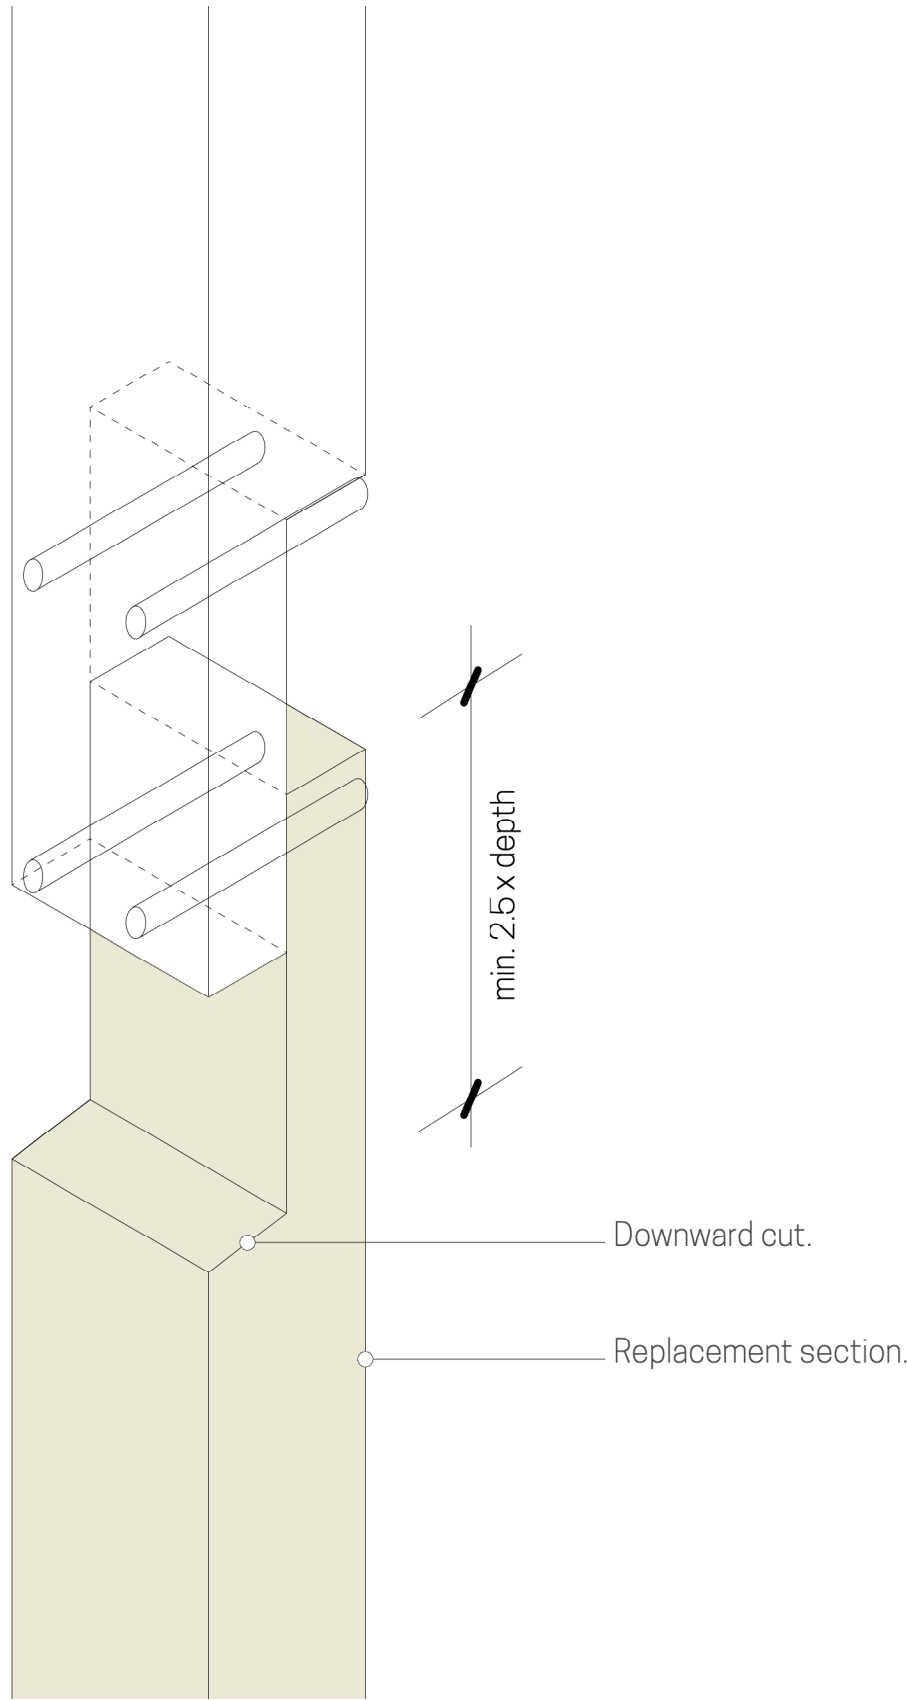
HALF SCARF JOINT - TO STUDS/POSTS  
Not to scale

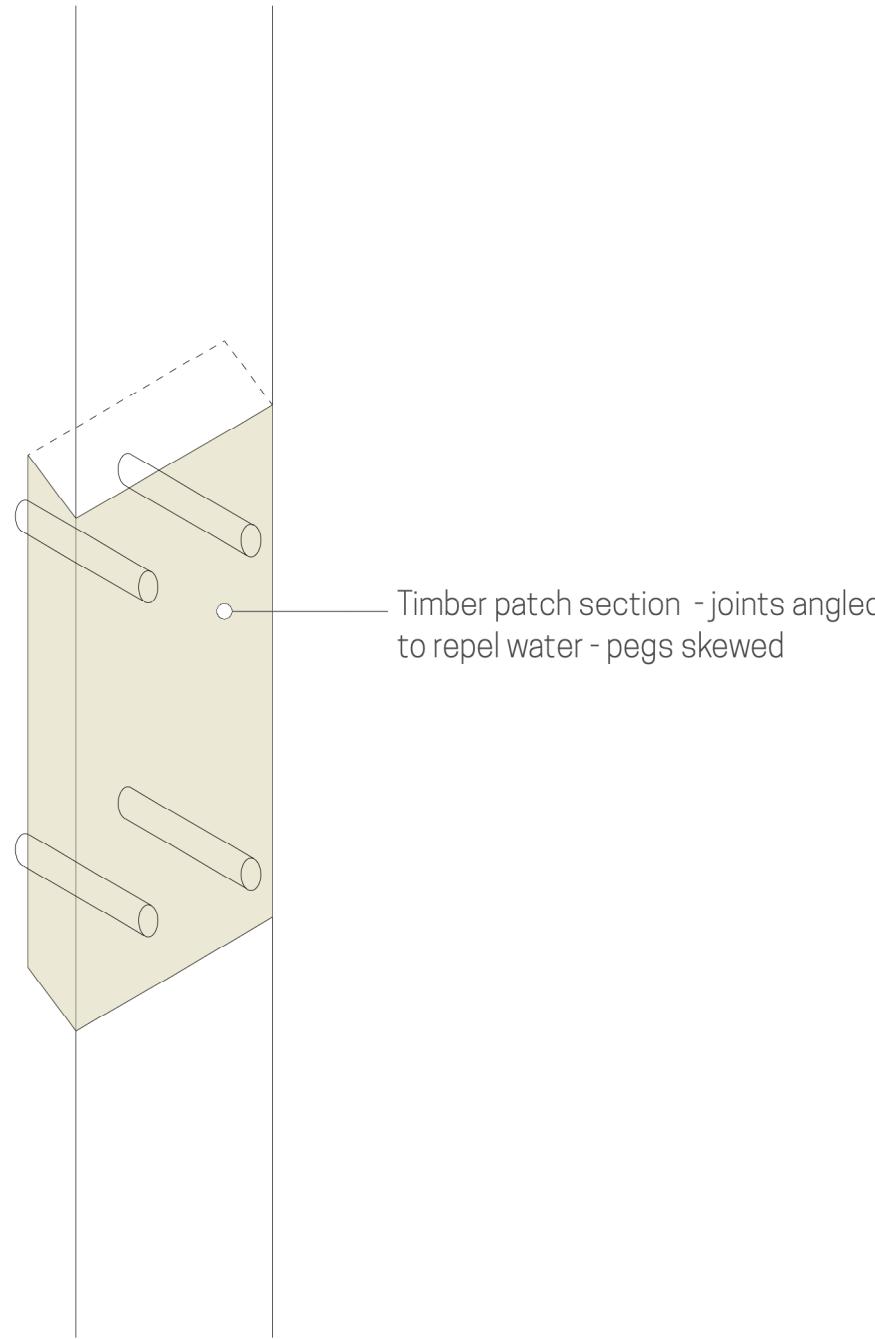
FACE REPAIR  
Not to scale

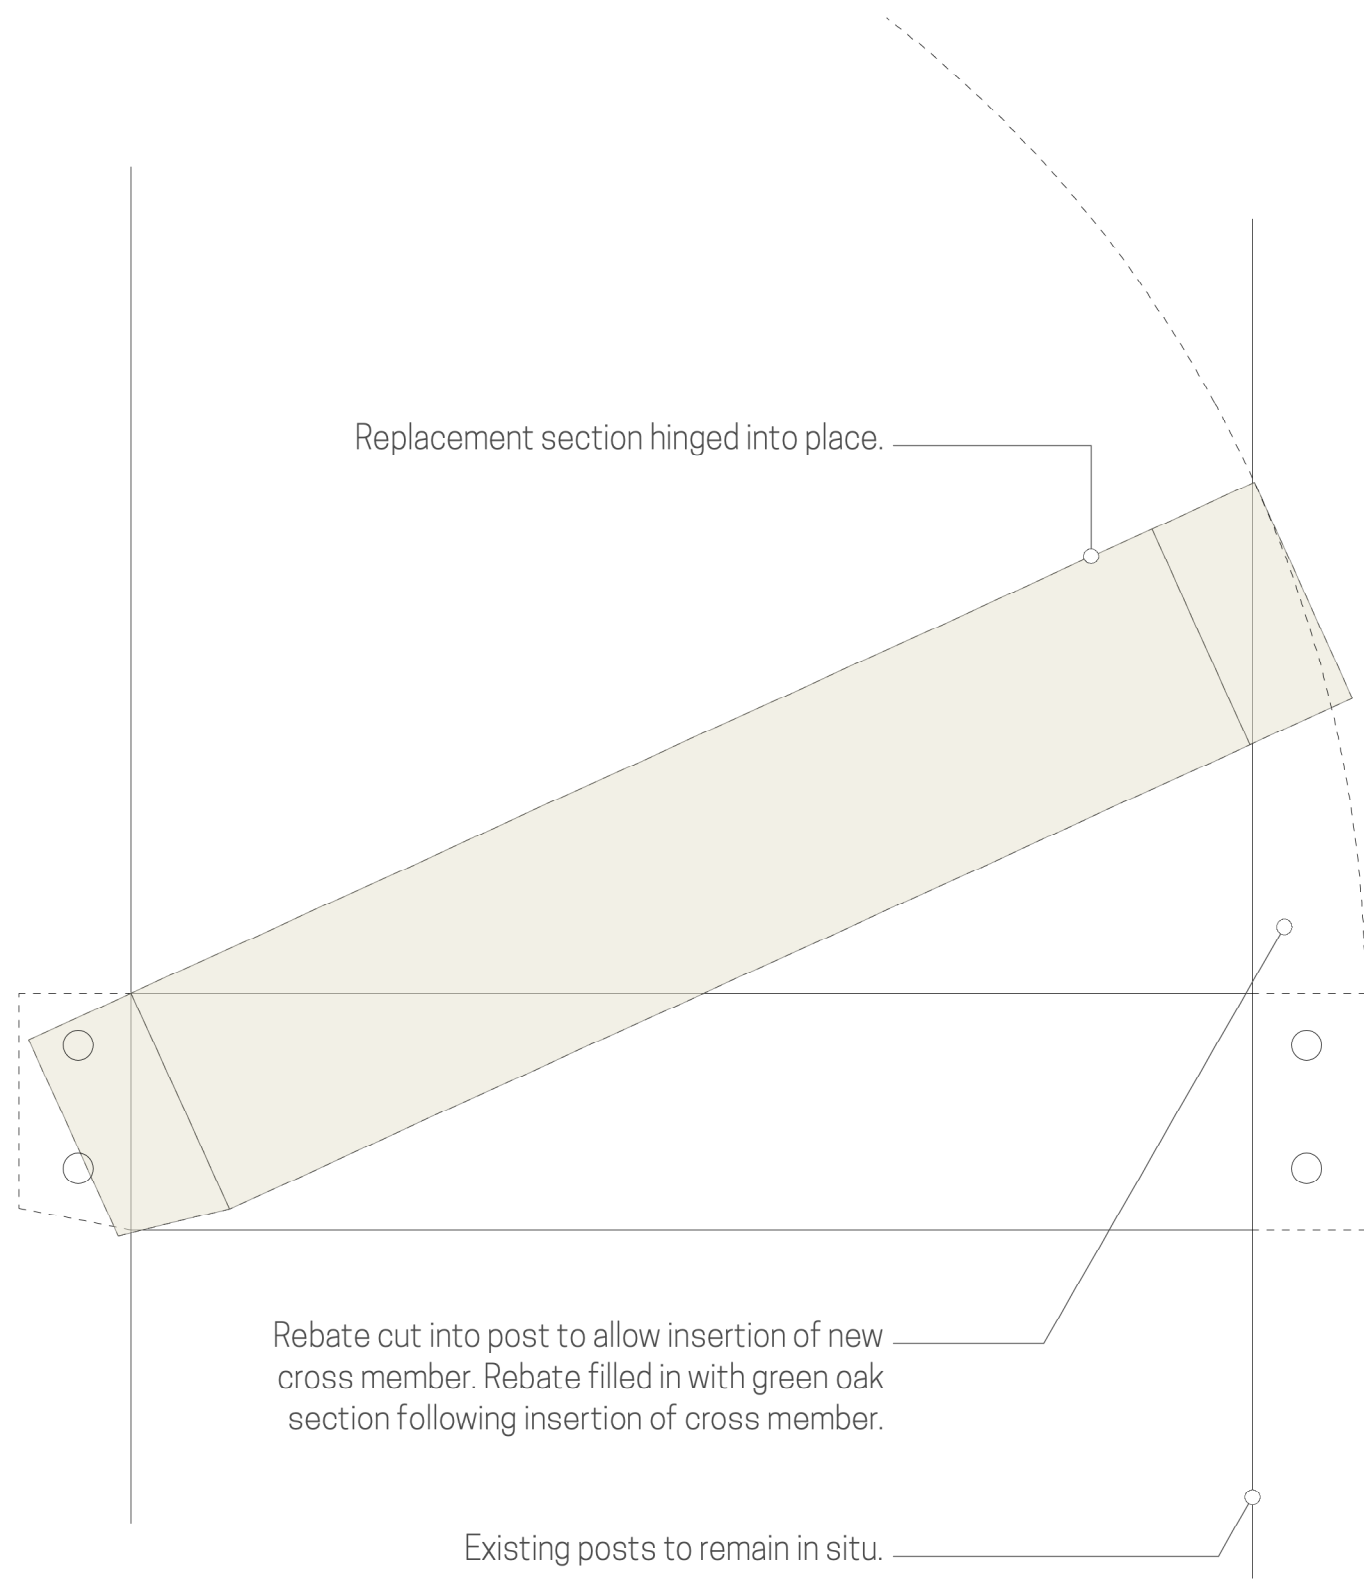
MID RAIL REPAIR  
Not to scale
