project
Lower Ponthendre, Longtown,
Herefordshire, HR2 0NY

drawing title
Proposed window W0.10 (Fixed unit)

drawing no.
5-3034

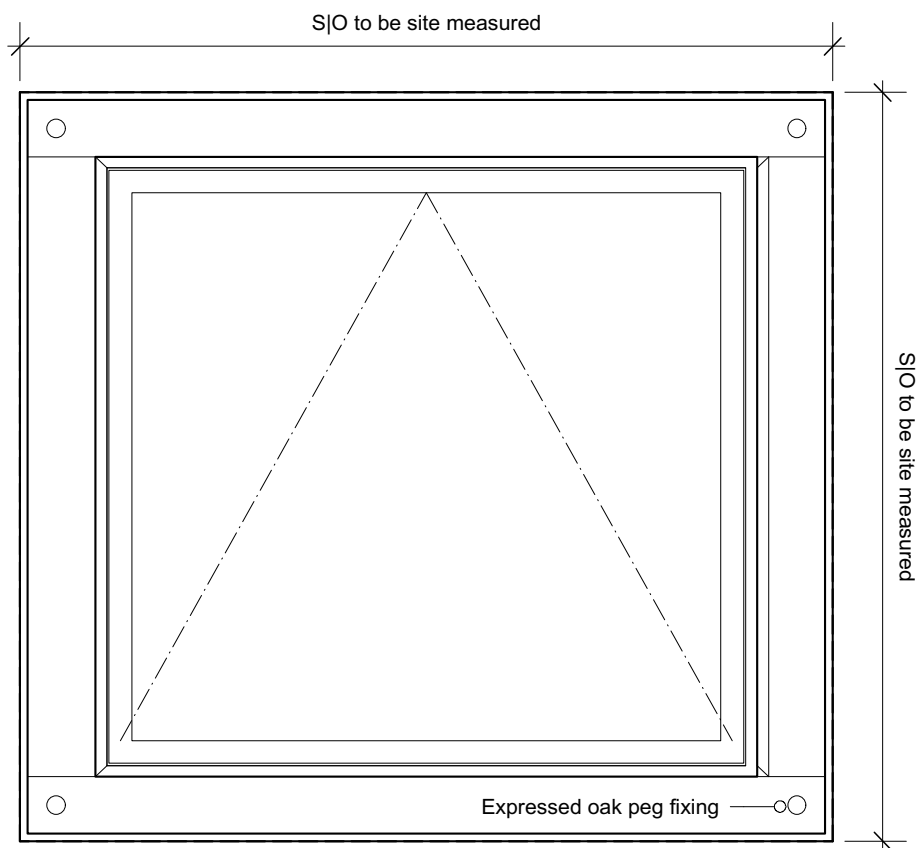
W0.10 External elevation
Scale: 1:10

Existing oak frame to be repaired and adapted to receive steel frame units. The majority of repairs to be spliced timber which will be angle cut so that if any water gets into the repair it is directed away from the building. Sensitive repairs to retain as much of the sound timber fabric and historic detailing as possible. All repair work directed towards the rear of the frame where achievable and in accordance with Historic England recommendations. All new joints a peg details to match existing.
