**UPPER HILL FARM BARN**  
Breinton, Herefordshire HR4 7PH

PROPOSED  
INTERNAL ELEVATIONS/TRUSSES

Drawing No. UHFb/1/15  
SCALE 1:100 @ A3

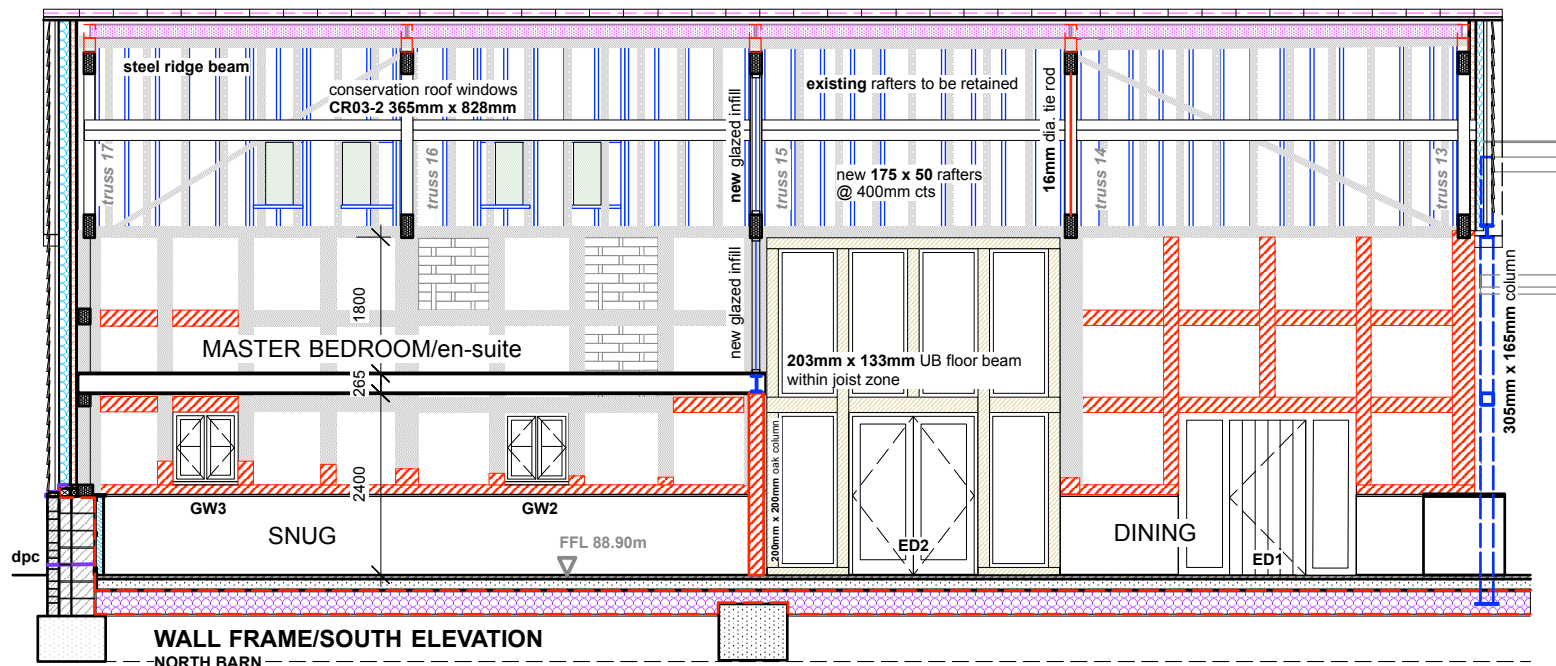
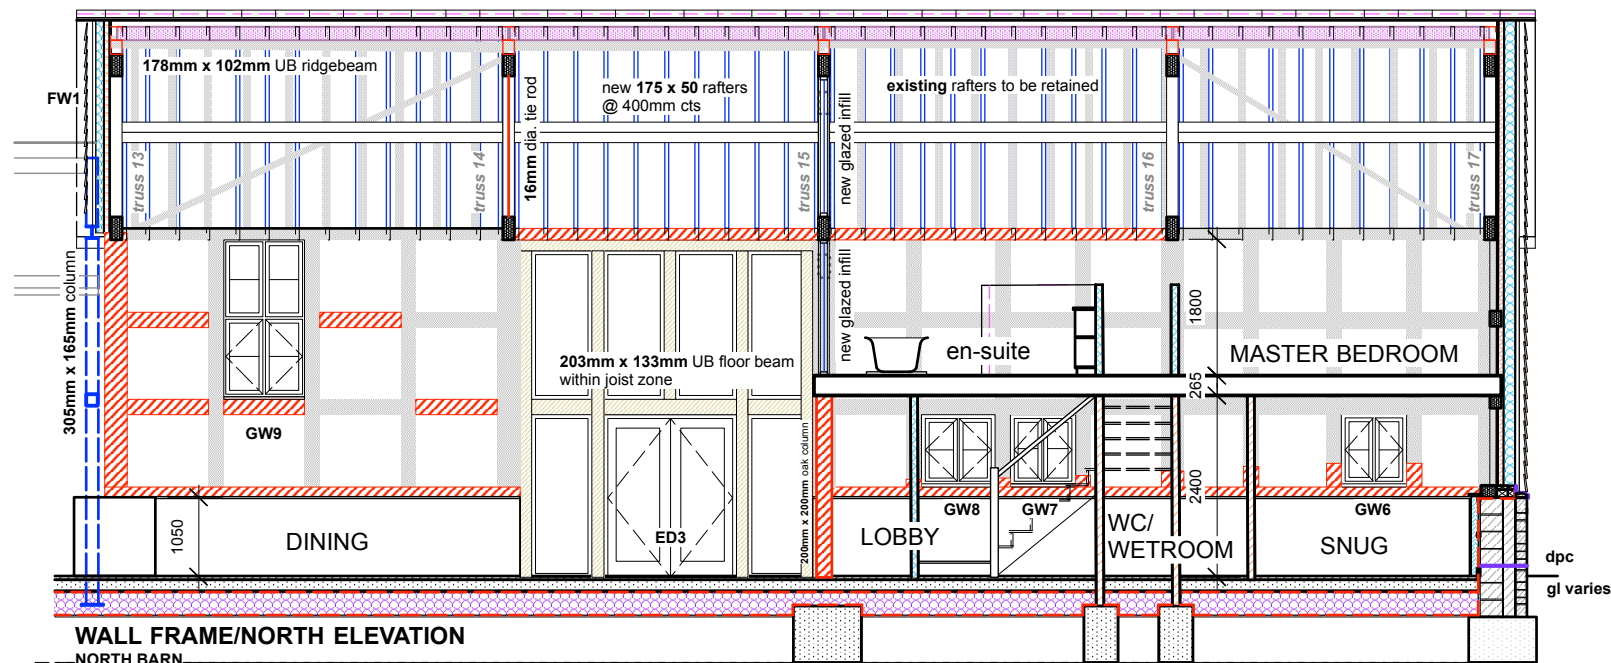
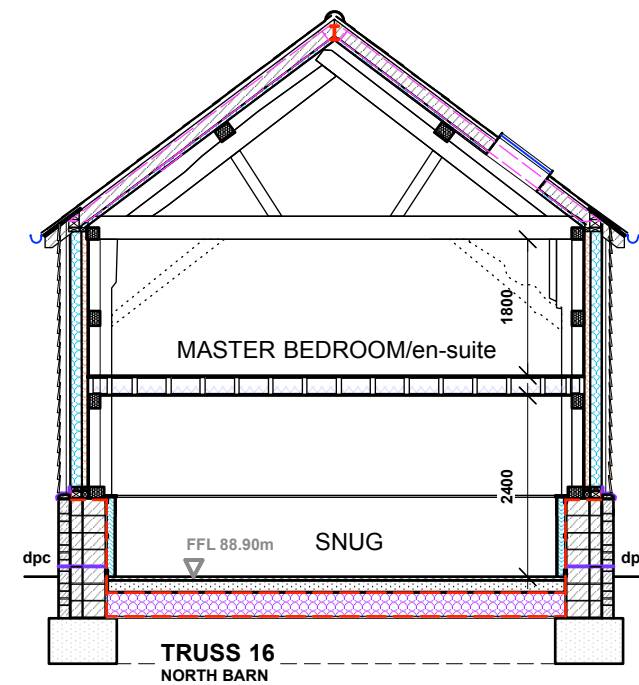
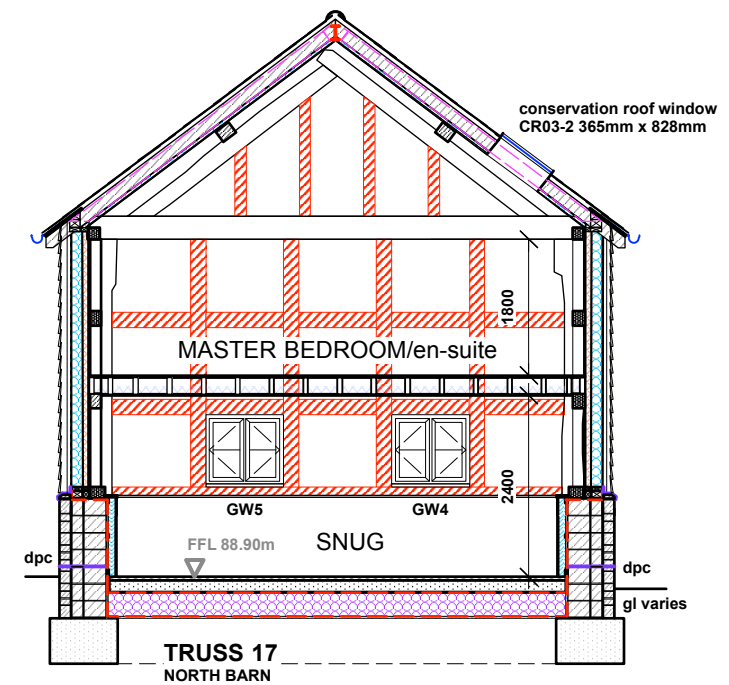
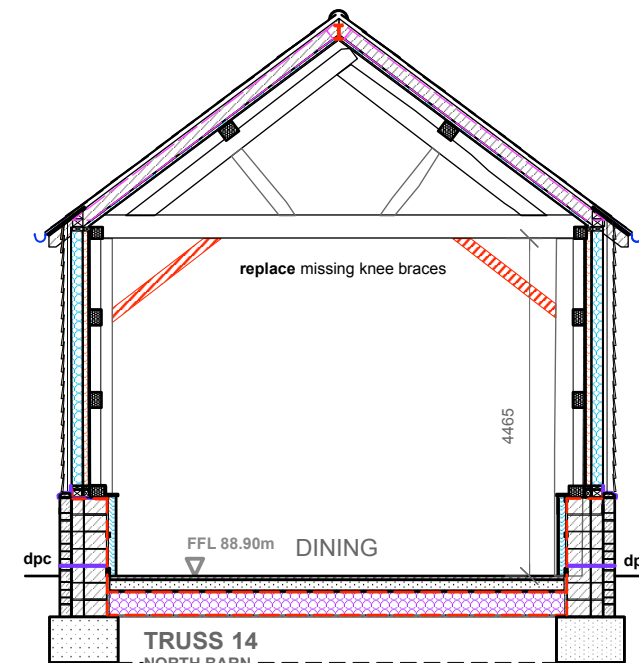
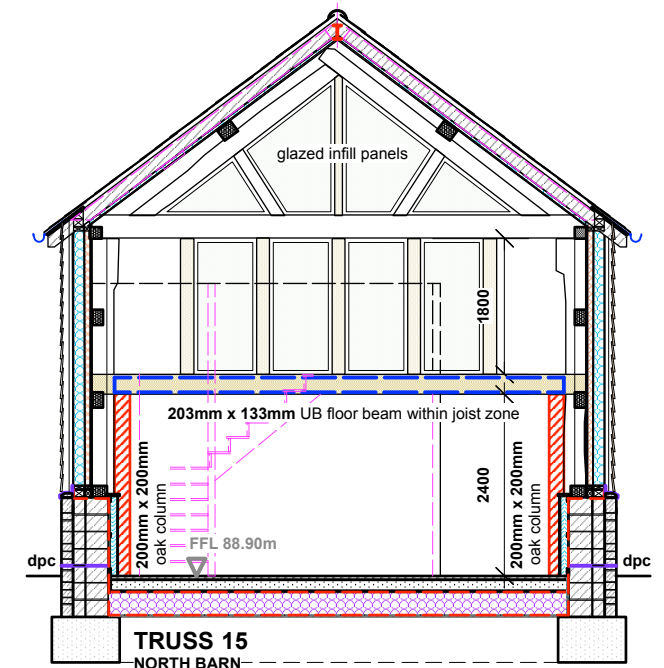
Insitu repairs to existing frames  
and new oak posts shown **RED**
