## **Tree survey and Categorisation to BS5837:2012 Arboricultural Impact Assessment**

**Proposed Tree House and Log Cabin Development at Sidney Nolan  
Trust, Presteigne, Herefordshire, LD8 2LL**

**Client: Sidney Nolan Trust,**

20 June 2023

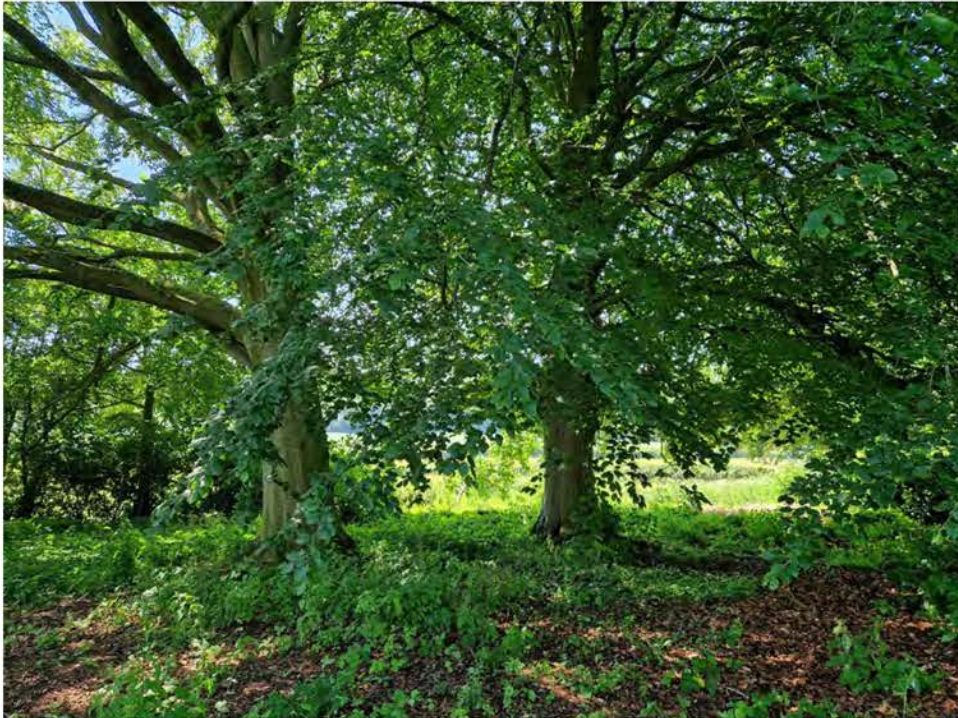
T1 and T2 with tree house location at rear

The proposal is within the RPAs of the major trees and a different methodology of construction has been researched and adopted. A low impact system is to be initiated using "Rapid Root" concrete free foundation system or similar approved to ensure no damage to tree roots of T1 and T2. Existing pedestrian access to the site is to be utilised which is external of RPAs on site, the new link from this existing access will be a surface mounted, no dig solution using bark and to be retained with wooden boards minimising potential impact or compaction.

| Tree No | Species | Diameter (mm) | | | Tree Height (m) | Lowest Branch M/dir | Branch Spread (m) | | | Life Stage | General Observations/Justifications | Recommendations | Priority | Life Expect | BS5837 Cat |
|---|---|---|---|--|---|---|---|---|--|---|---|---|---|---|---|
| T1 | Fagus syl | 1080 | | | 22 | 1 | 11 | 10 | | M | good example of mature trees grown as pair | general monitoring | | 40+ | A1 |
| T2 | Fagus syl | 1000 | | | 21 | 1 | 12 | 11 | | M | good example of mature trees grown as pair | general monitoring | | 40+ | A1 |

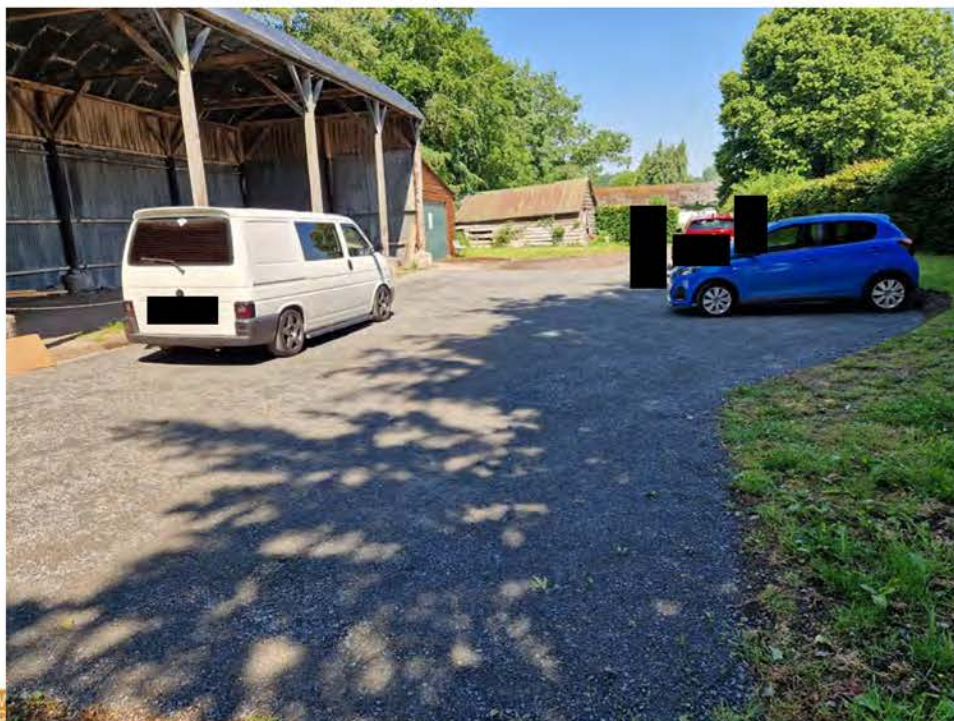
Parking area to be  
utilised for storage

Material storage can take place upon the existing hardstanding and carparking areas and moved onto site when required, further reducing the potential effects of compaction.

Existing hardstanding and parking areas are to be utilised for contractors parking and material storage and will not require additional construction, should this change, low impact system should be used and located external of all RPAs on site.

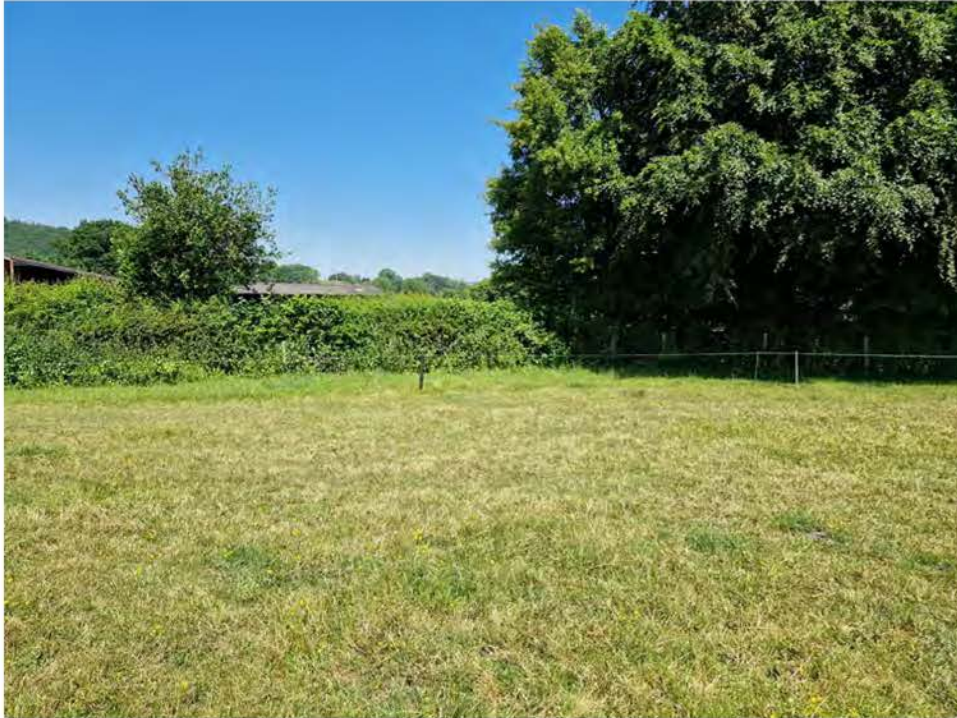
Log cabin location

This is a free standing structure located within a short improved grassland field, it is external of a small block of young woodland, this location is external of trees RPAs and its footpath access is proposed across the grassland and also does not affect any trees, this location requires minimal consideration

The proposed new structure is external of all RPAs and no tree canopies are affected, the proposed new footpath is also external and will be of a similar low impact bark/gravel solution.

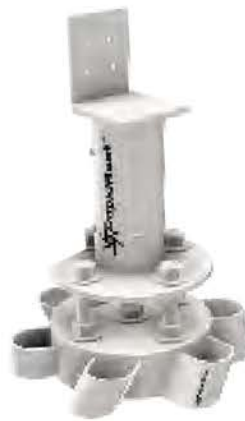
### **RR6**

6 Pile model with capacities up to 120kN in typical soils.

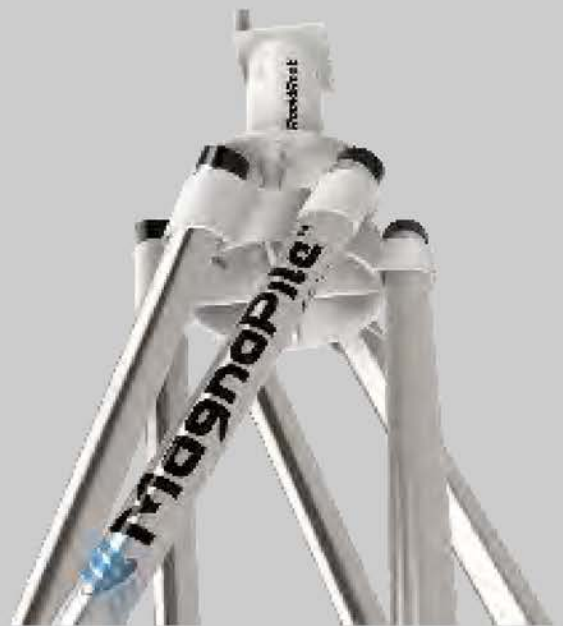
MagnaPile is our proprietary magnesium–alu–zinc alloy coated pile and is at the heart of our systems. These are high tensile steel piles with ultra high corrosion resistance far superior to standard hot dip galvanisation. MagnaPile meets the design requirements of residential and civil works in even the most corrosive soil types.

This isn't just a coating, there is a manufacturing method behind this and years of research and development that guarantees the integrity of the protection during the life of the project. Nothing else on the market that compares.

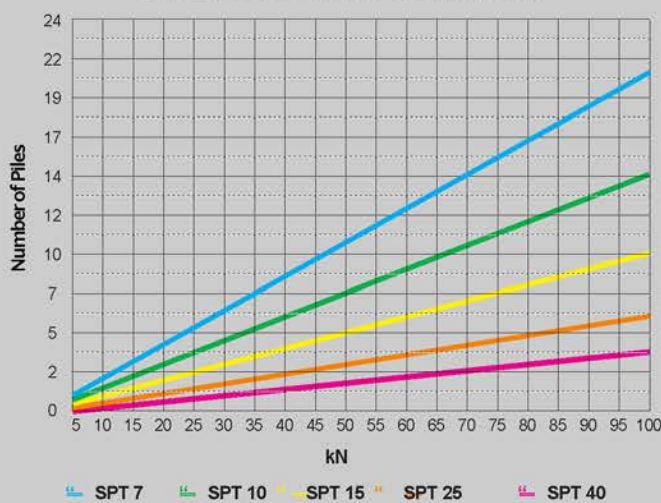
COMPRESSION - PILES L=2m [60,3 mm]

Approximate loading guide in both compression and traction based on given kN load and a given soil SPT bore hole value. This example is fixed for fixed length 2m piles and serves only a rough example of capacities. Actual pile cap specification and pile depths must be calculated by a qualified engineer.
